# REAL ESTATE INSPECTIONS

Date of Inspection: 2/11/2012

### Property Analysis Report

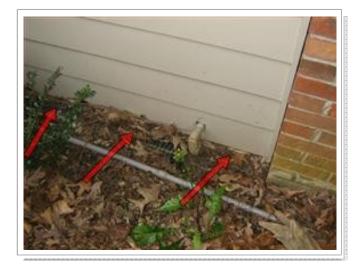
Siding at the front of the carport is in ground contact or too close to the soil, 6 inches of clearance to grade is recommended to prevent decay and infestation by wood destroying organisms. Recommend improving clearances.

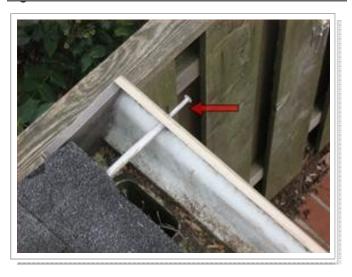
The gutter at the carport are loose and need to be secured.

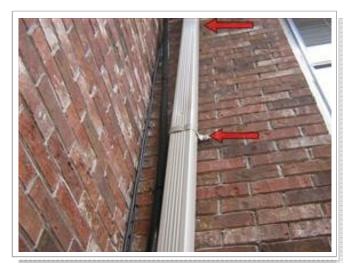
The downspout at the right rear is loose and needs to be secured.

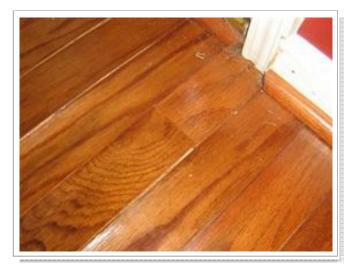
The wood flooring throughout the 1st floor has cupped indicating moisture. Moisture meter was used at front and rear rooms and the flooring is dry. Told that broken sewer main caused original leak that entered home. The floor will need replacement as it is a tripping hazard.

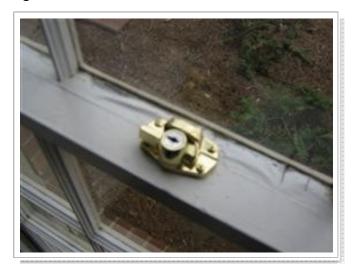
### Figure Number 5

The keys are missing on the windows in the living room. Provide keys or replace lock.

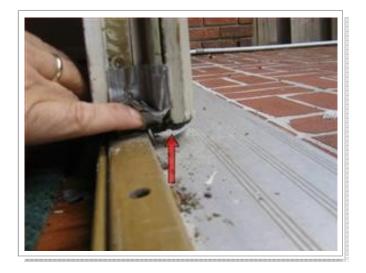
### Figure Number 6

The left double door to the kitchen binds and will not open to the patio. Appears center astragal strip is binding door. Repair.

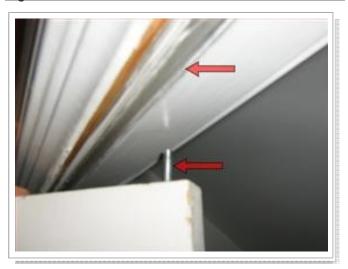
### Figure Number 7

The hinge pins are missing or damaged on numerous double closet doors. Replace hardware as needed.

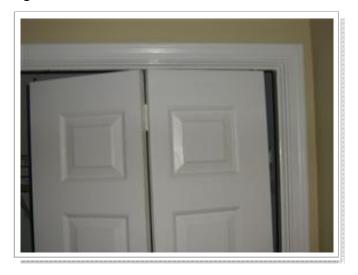
The hinge pins are missing or damaged on numerous double closet doors. Replace hardware as needed.

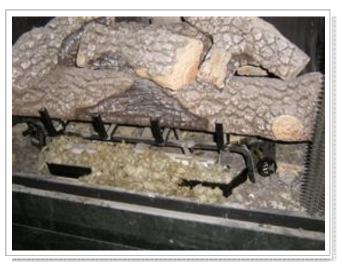
The gas starter at the fireplace did not work when tested. Repair as needed.

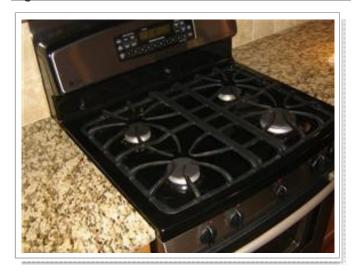
The anti tip device is missing for the range. Install as needed.

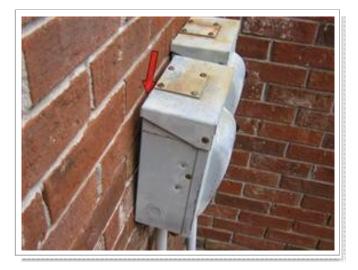
The electric disconnect can is loose at left rear exterior. Properly secure to wall.

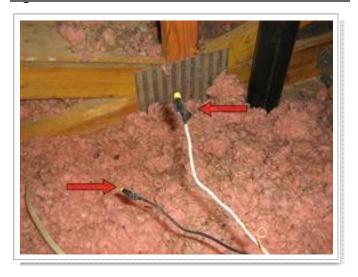
## Figure Number 12

Flying wire splices were observed at the attic. All splices should be contained in closed junction boxes. Correct wiring as needed.

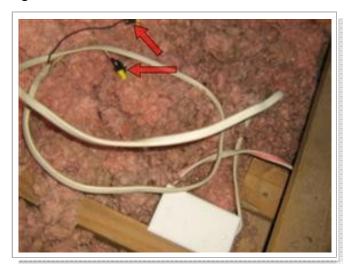
### Figure Number 13

Flying wire splices were observed at the attic. All splices should be contained in closed junction boxes. Correct wiring as needed.

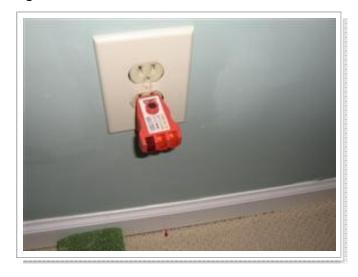
A receptacle is damaged in the master bedroom-right side . Replace receptacle.

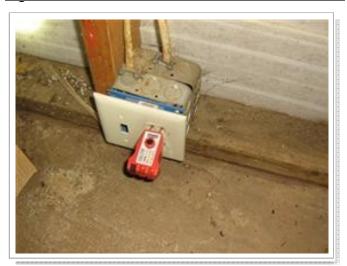
${\sf GFCI}$  protection is missing for the receptacle in the carport and storage. Install  ${\sf GFCI}$  protection.

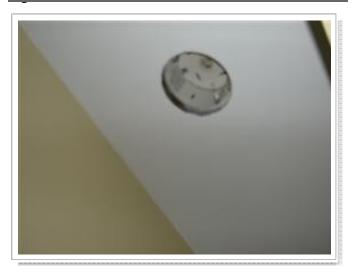
The light in the upper hall shower did not work when tested. Check for blown bulbs, repair fixture if needed.

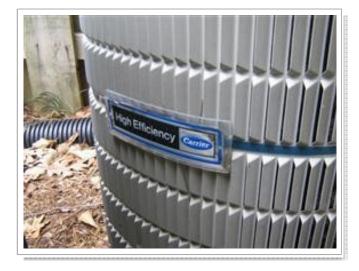
The cooling systems/ condensers are older (1994 & 1984) and has reached its average life expectancy. Replacement may be required at anytime.

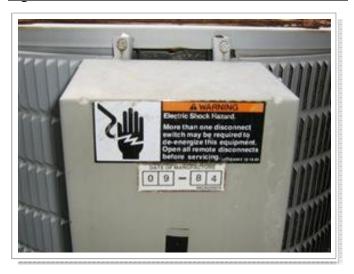
#### Figure Number 18

The cooling systems/ condensers are older (1994 & 1984) and has reached its average life expectancy. Replacement may be required at anytime.

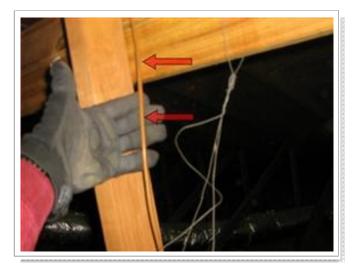
No insulation is installed on a waterline to humidifier in the attic. Water line could freeze and burst. Install insulation where missing.

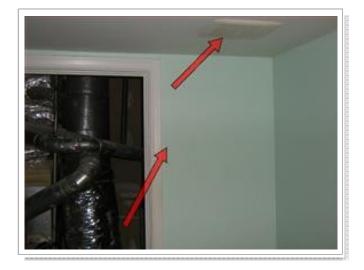
### Figure Number 21

When turned on the powder room exhaust fan draws combustion products (carbon monoxide) from the furnace and water heater. Inadequate combustion air was observed to the furnace and water heater at closet. Recommend combustion air vents be added to furnace closet.

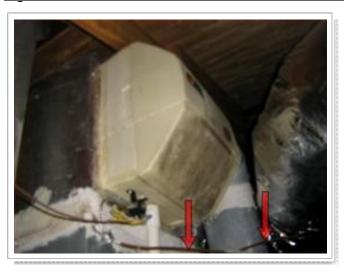
### Figure Number 20

No insulation is installed on a waterline to humidifier in the attic. Water line could freeze and burst. Install insulation where missing.

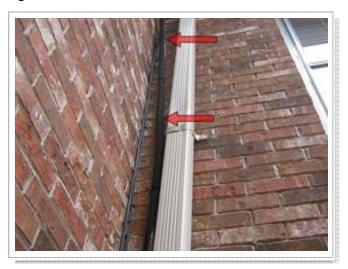
### Figure Number 22

The Freon lines at right exterior do not have adequate support. Lines should be supported at 6-foot intervals. Add support as needed.

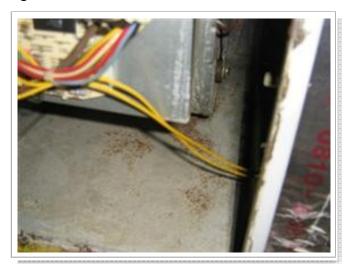
The blower motor and housing in the air handler for the main floor HVAC system is corroded. Recommend system be cleaned and evaluated by a qualified HVAC technician.

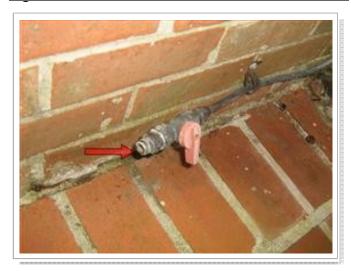
#### Figure Number 24

An uncapped gas line was observed at the rear patio. Cap the line.

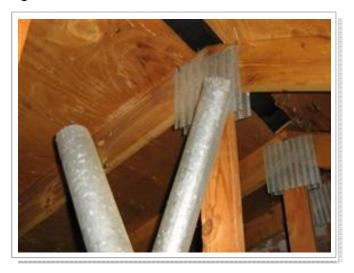
### Figure Number 25

The bathroom exhaust fans are vented into the attic. Fans should be vented to the exterior.

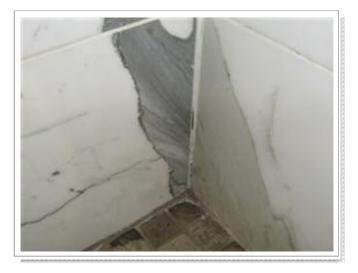
Grout is missing or deteriorated in the master bathroom shower. Regrout/repair as needed.  $\label{eq:continuous}$

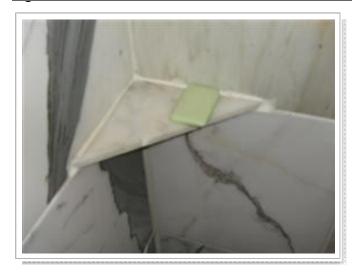
## Figure Number 27

Tile shelves are cracked in master shower. Repair/replace.

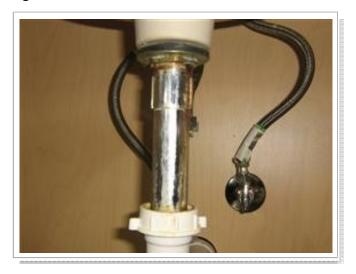
### Figure Number 28

A leak was observed at a joint in the tailpiece under the master sink. Repair.

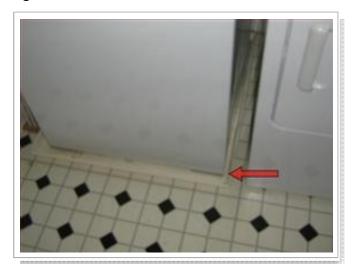
Drip pan under wash machine to prevent water damage if leaks occur is not connected to an exterior discharge pipe. Install pipe to exterior or install a water alarm in pan.

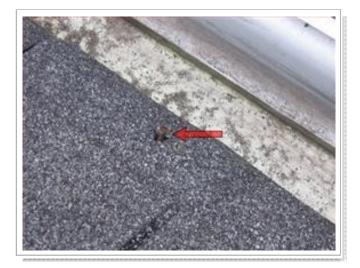
Nails have worked out of the roof sheathing and through the roof covering at rear of car port. Recommend loose nails be pulled and the holes in the covering sealed to prevent leaks from developing.

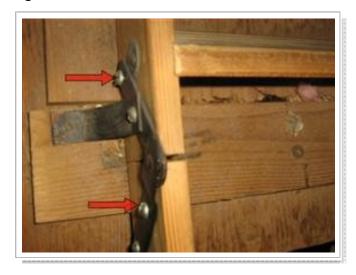
### Figure Number 31

Loose or missing nuts and bolts were observed on the pull down stairs to the attic. Tighten and replace missing hardware as needed.

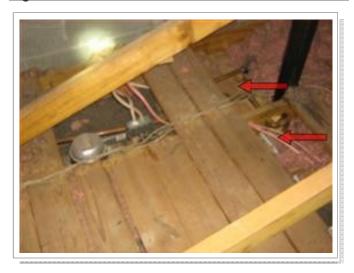
### Figure Number 32

The depth of insulation above the ceilings is low by today's standards. Recommend installation of additional insulation to improve energy efficiency. A minimum of R-30 insulation is recommended.

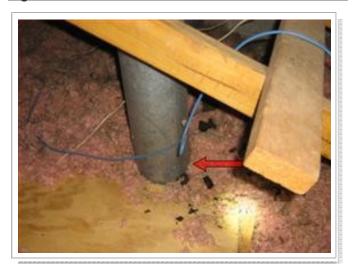
### Figure Number 33

Insulation against flue pipe in attic. One inch clearance is required from combustibles on a type B flue pipe. Insulation is considered combustible. Modify Insulation away from flue, install collar.
