Property Condition Assessment

Champia Real Estate Inspections, LLC

Date: 3/29/2018	Time: 09:00:00 AM	Report ID: 31646
Property: [REDACTED]	Customer: [REDACTED]	Real Estate Professional: [REDACTED]

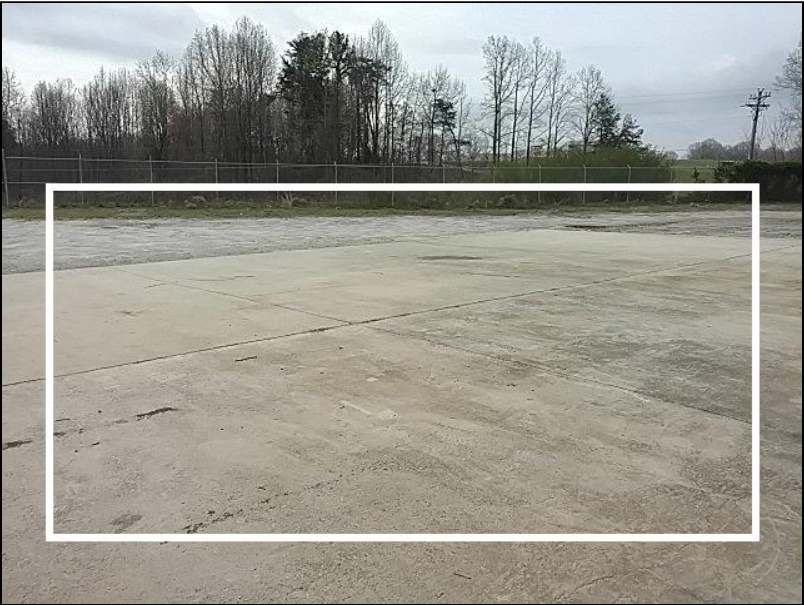
D. Cracks noted at rear driveway. Some of the parking area is not paved. Repair/replace as necessary.

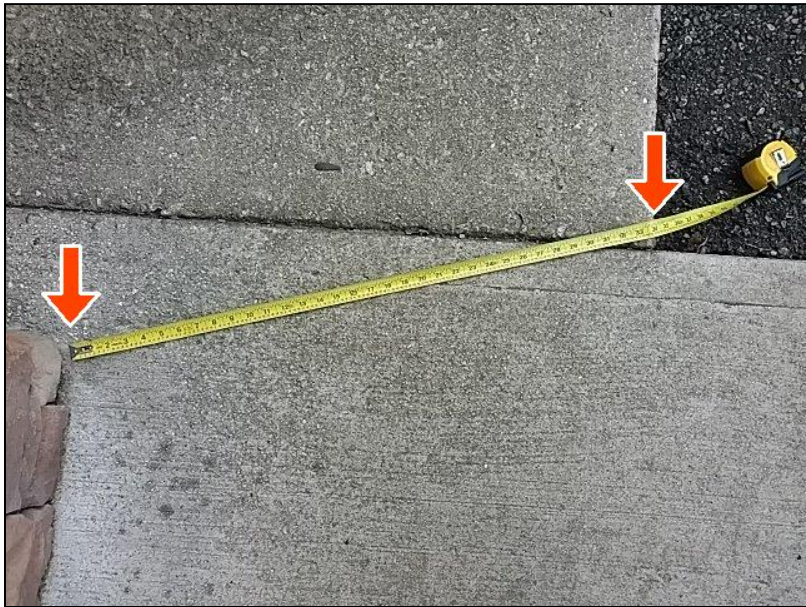
Front sidewalk

E. (1) Intersection between sidewalk and front stoop is too narrow for wheelchair use. NOTE: Path widths for wheel chairs should be at least 36" wide. Repair as necessary.

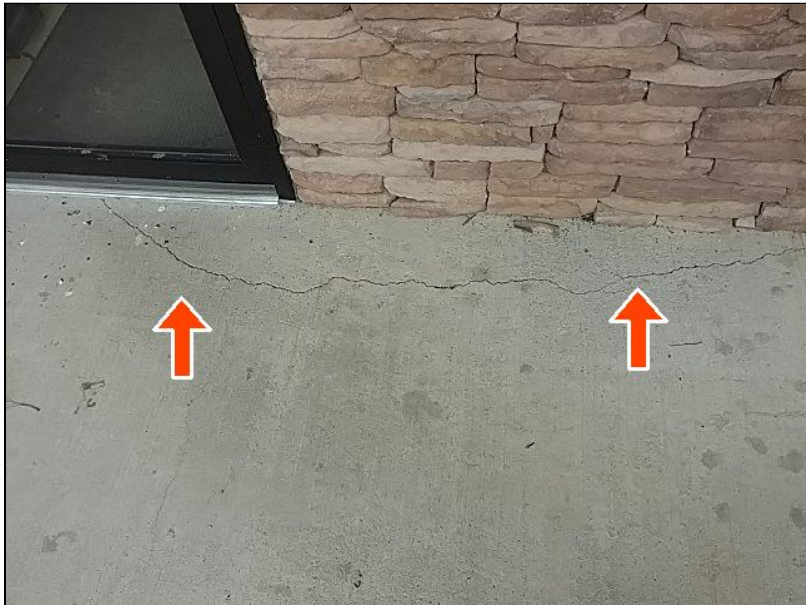
Front

E. (2) Cracks noted at front walkway. Recommend to seal cracks/repair/replace as necessary to avoid moisture entry.

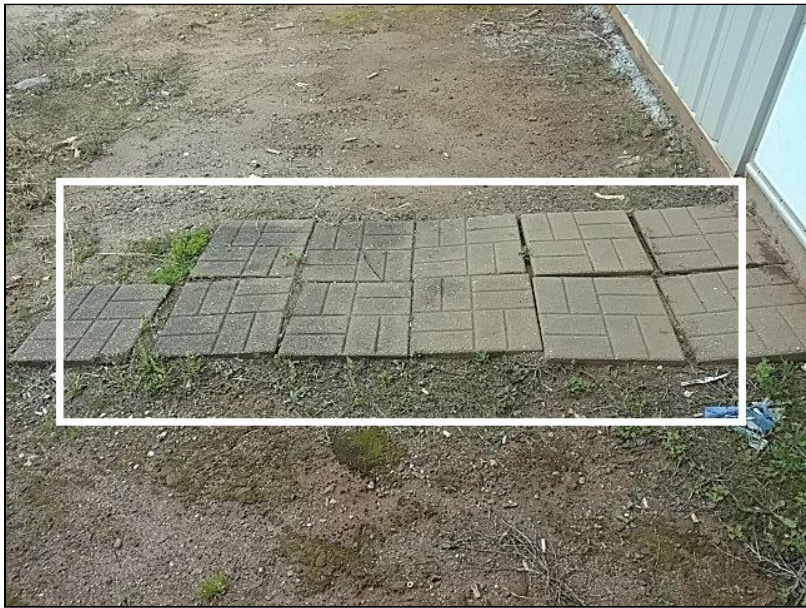
Right

E. (3) Displaced/damaged pavers noted at right side driveway. Repair/replace as necessary to avoid trip hazard.

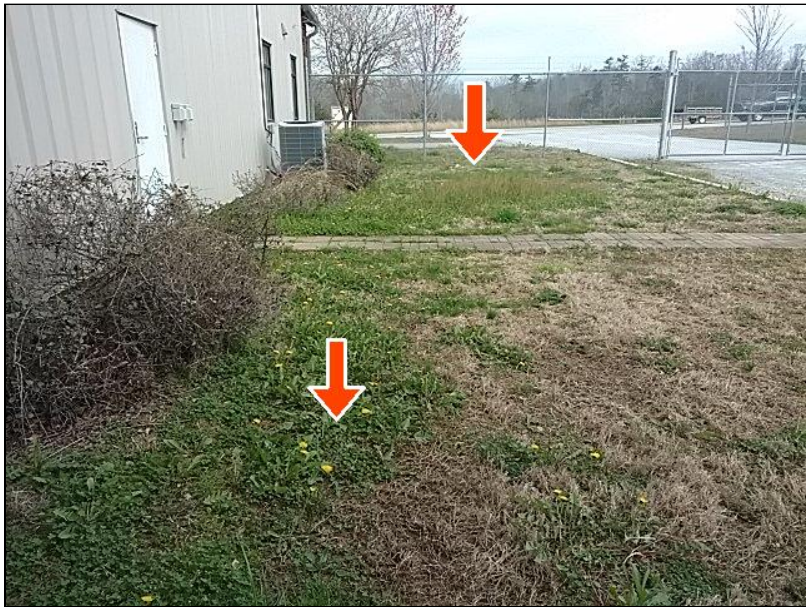
Left side

F. (1) Flat grade note at left side. NOTE: Flat or reverse grading can lead to standing water and flooding to the interior. Recommend to install proper slope. NOTE: i.e. 6" within the first 10 ft.

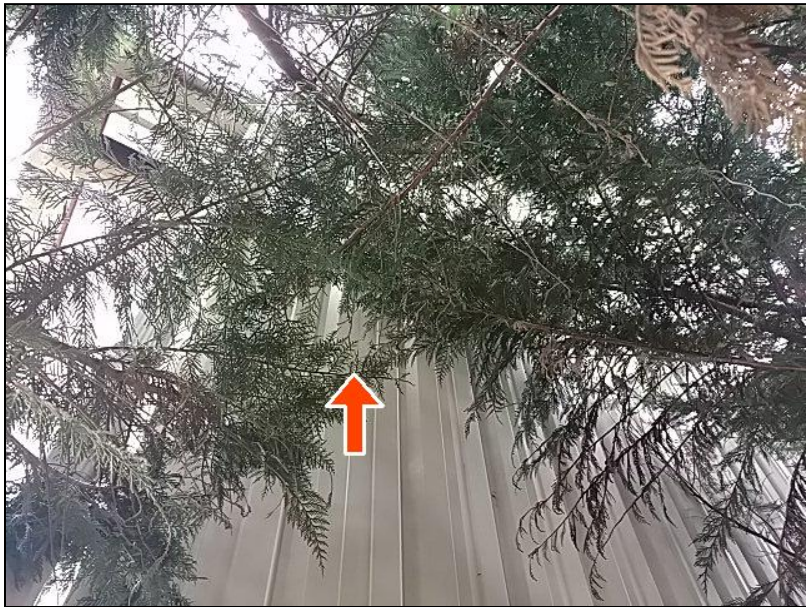
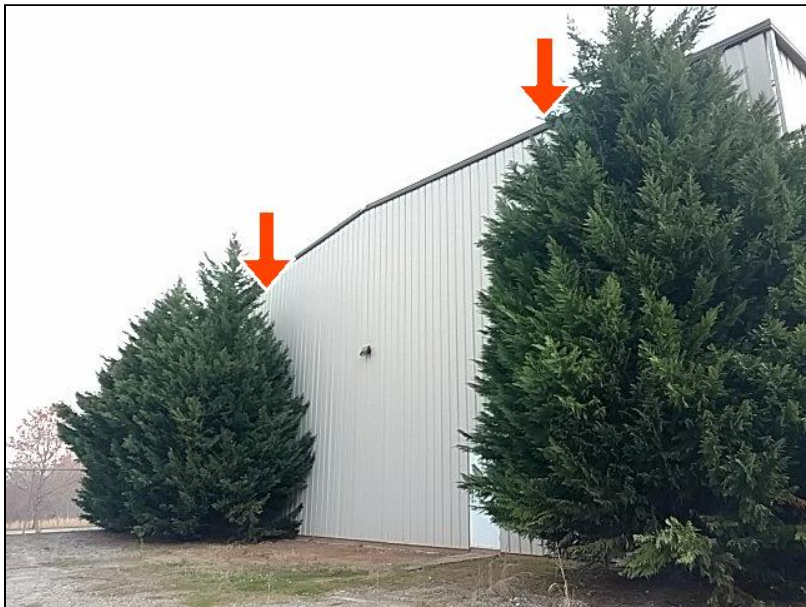
F. (2) Tree branches in touch with the exterior and observed at rear left and right sides. A minimum clearance between branches/vegetation and cladding/roof should be maintained to avoid damage. Adjust/remove trees as necessary.

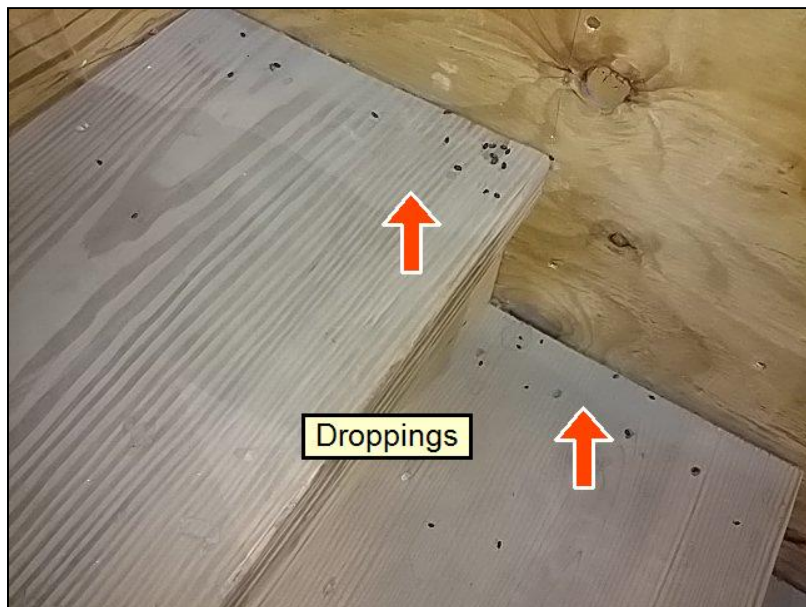
Interior stairs

F. (3) Signs of animal activity noted at the interior (droppings). Recommend evaluation by a licensed wildlife and pest control service.

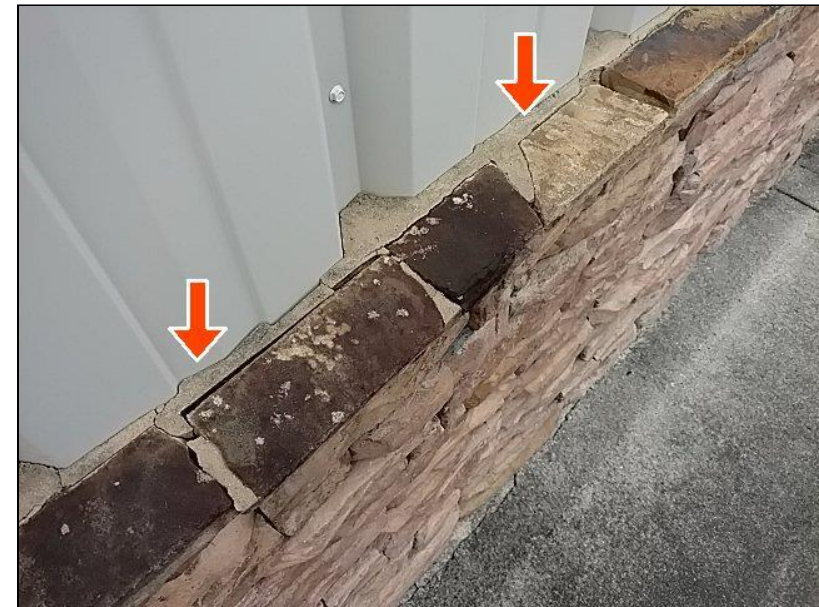
Example: Front

C. (1) Improper installation of stone veneer suspected. The veneer stone across the front appears to be install directly onto the metal siding. NOTE: Adhered stone veneer typically requires a vapor barrier and mesh to adhere to. Recommend further evaluation by a licensed contractor.

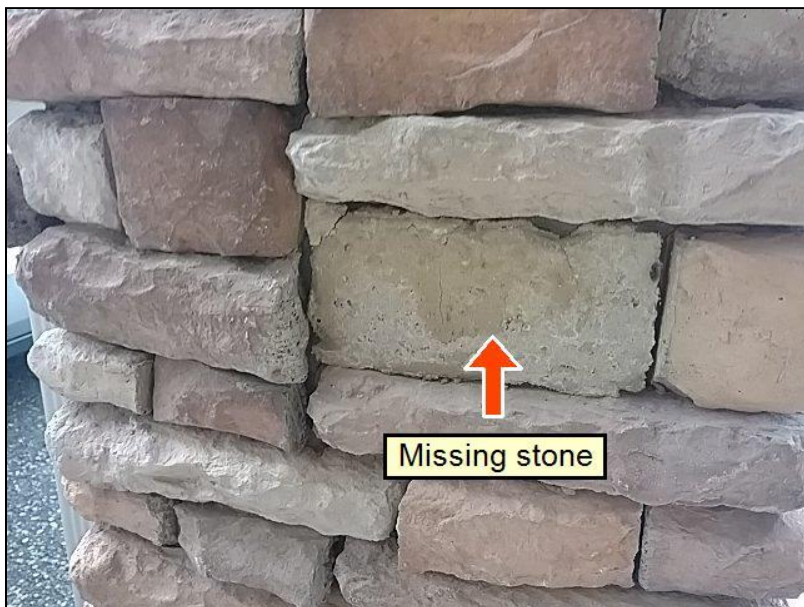
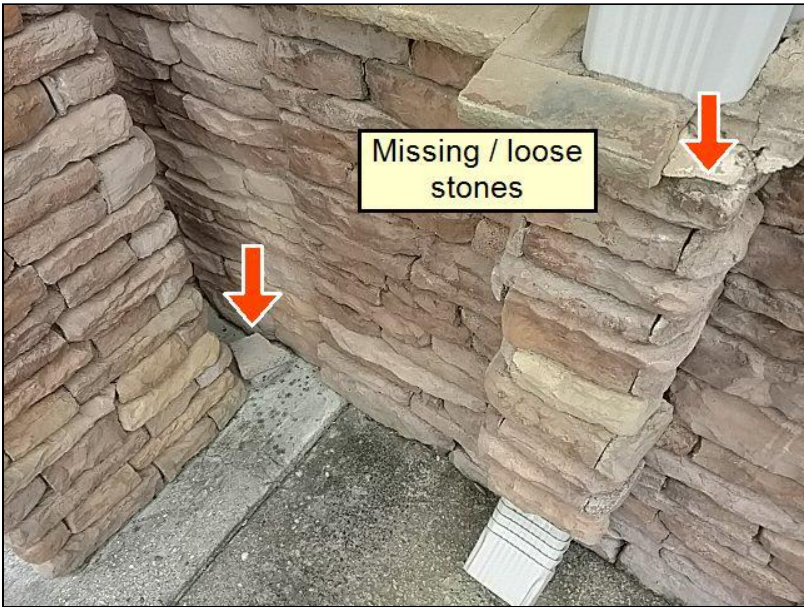
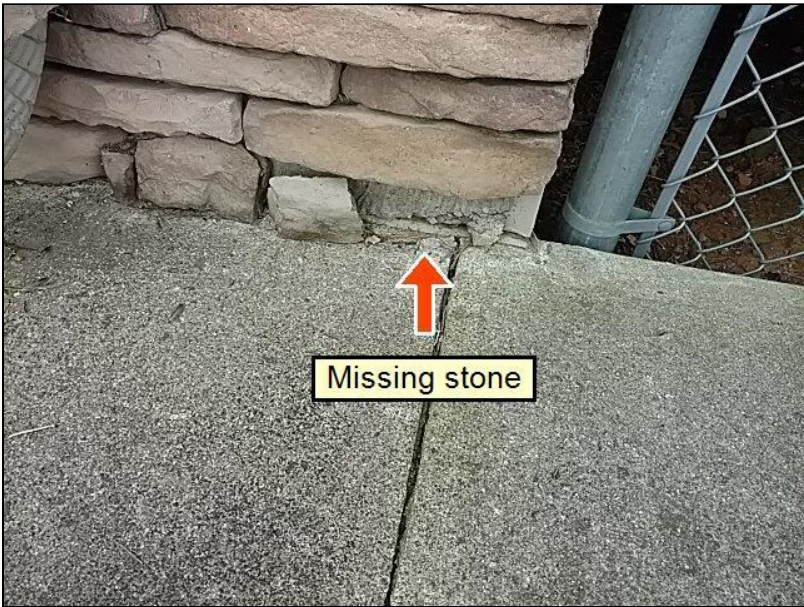
C. (2) Damage/separation noted at front stone veneer at numerous locations. Refer to images for typical locations and refer to previous comment for related observations.

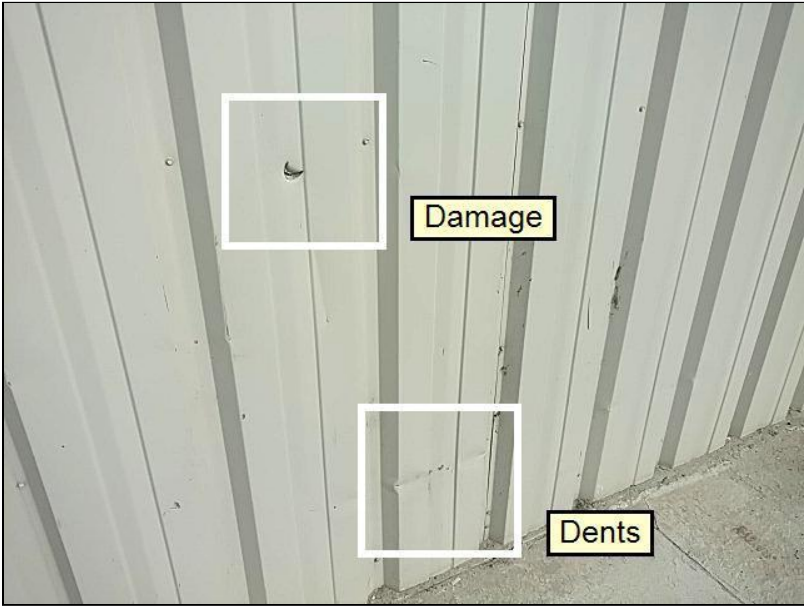
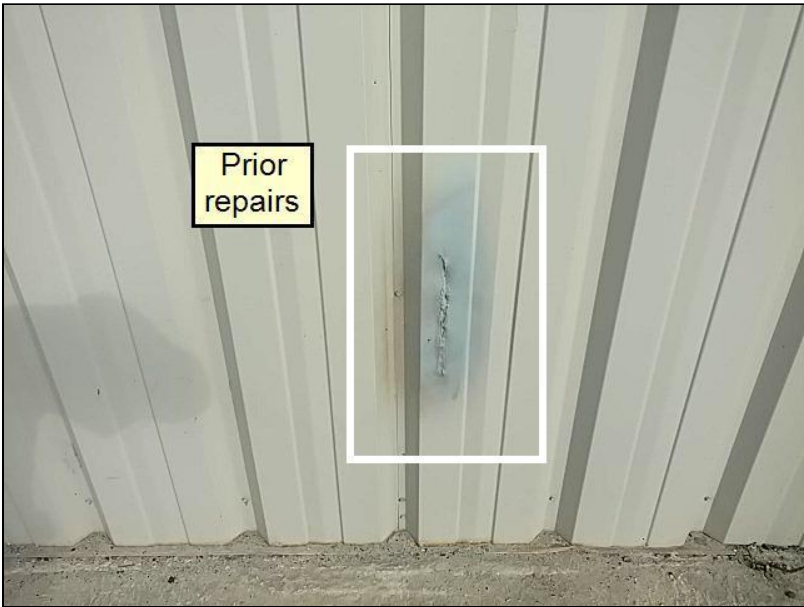
C. (3) Minor damage noted at rear metal siding. Repair as necessary.

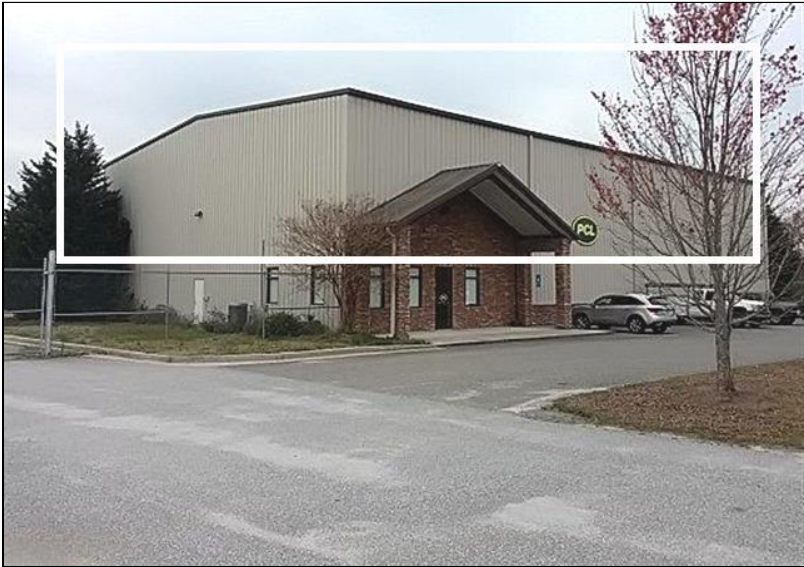
E. NOTE: The roof area wa not accessible. Recommend evaluation by a licensed roofing contractor.

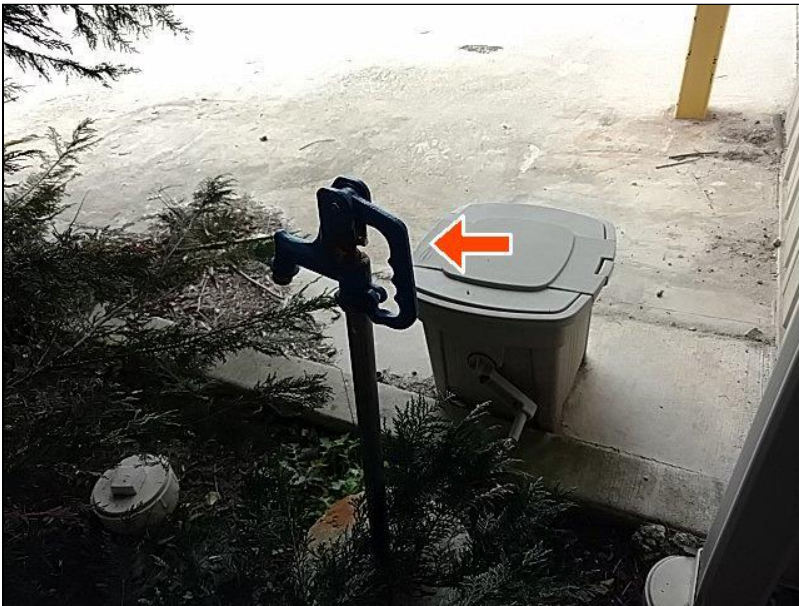
This location: Rear left

A. (1) Manual hand pumps noted at front and rear left corners. The handle(s) are hard to operate. Recommend service.

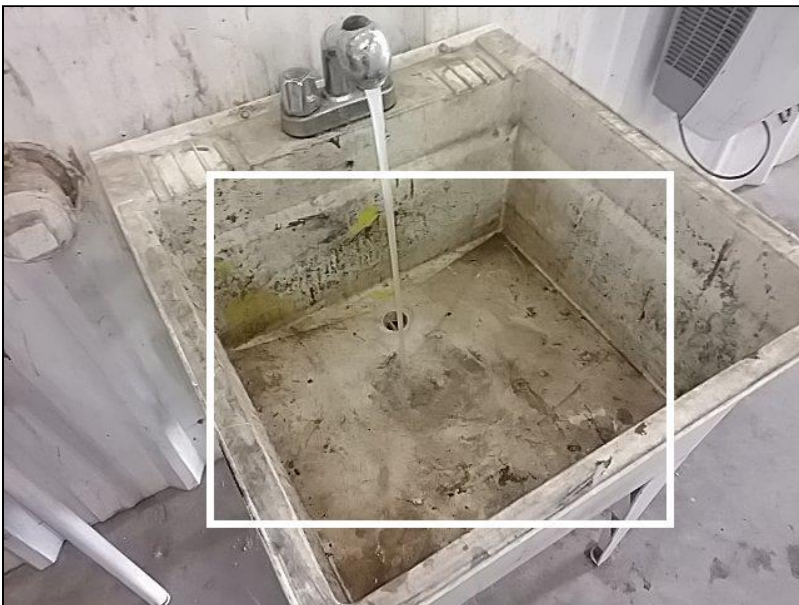
Warehouse

A. (2) The sink in the warehouse is severely soiled. Recommend replacement.

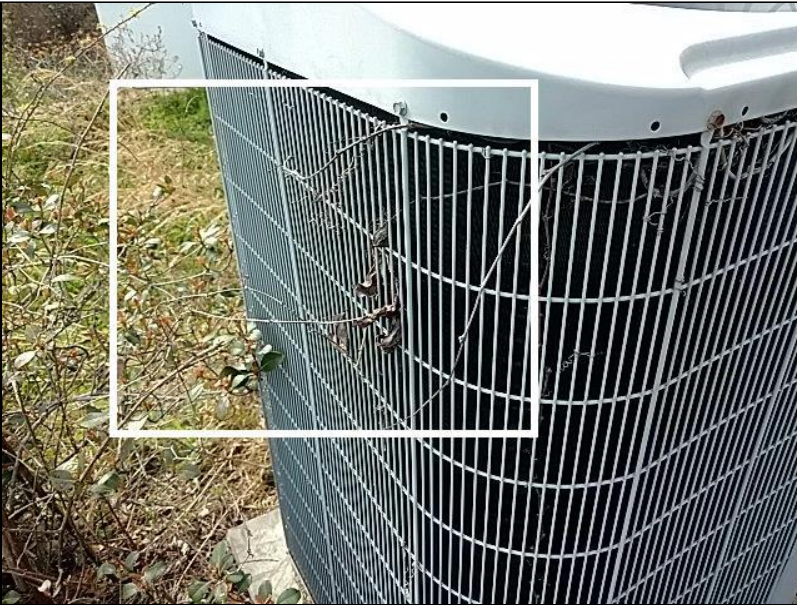
AC unit

D. (3) Intrusion of vines noted at the AC screen. NOTE: AV screens should be kept clear of intrusions to maximize performance.

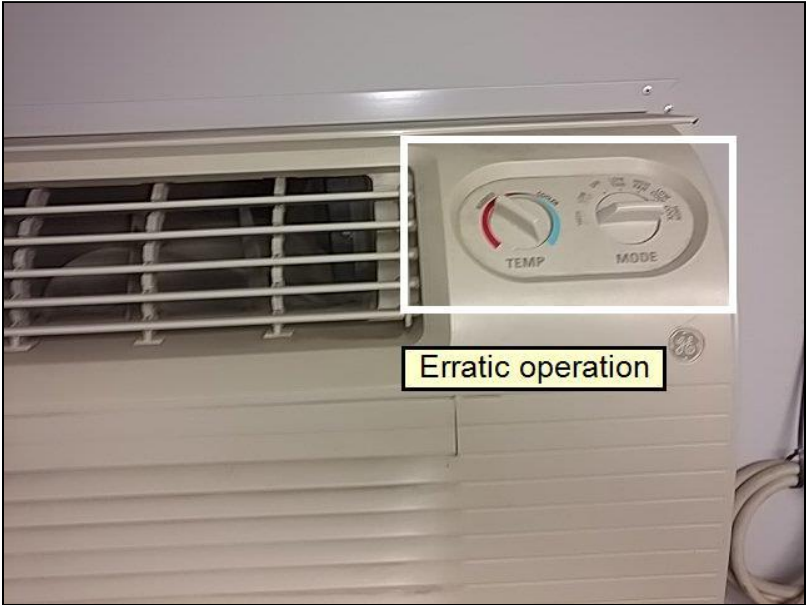
Warehouse office

D. (4) The AC wall unit in the warehouse office did not operate reliably/shut down after start up. Recommend further evaluation by a licensed contractor.

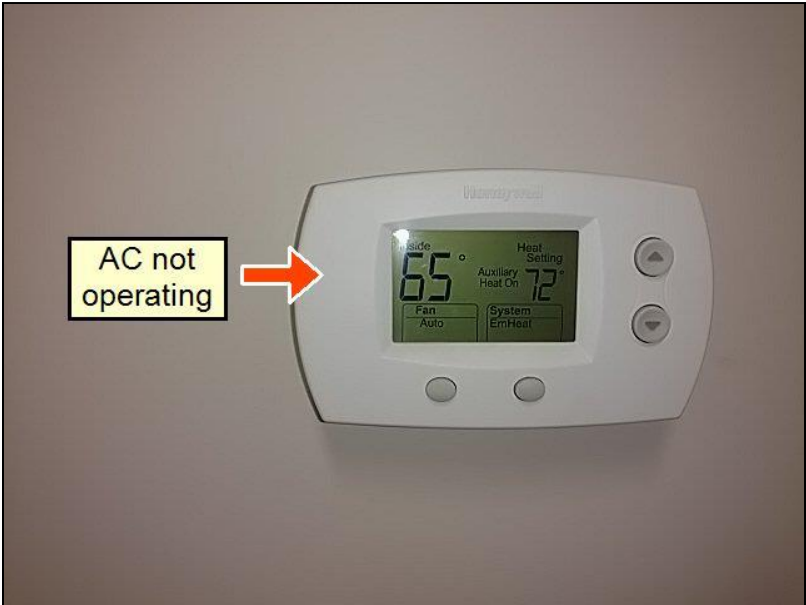
D. (5) The AC unit/heat for the front office area did not operate. Unable to test air conditioning and heating in this area. Evaluate AC/heating units/thermostat and repair/replace as necessary.

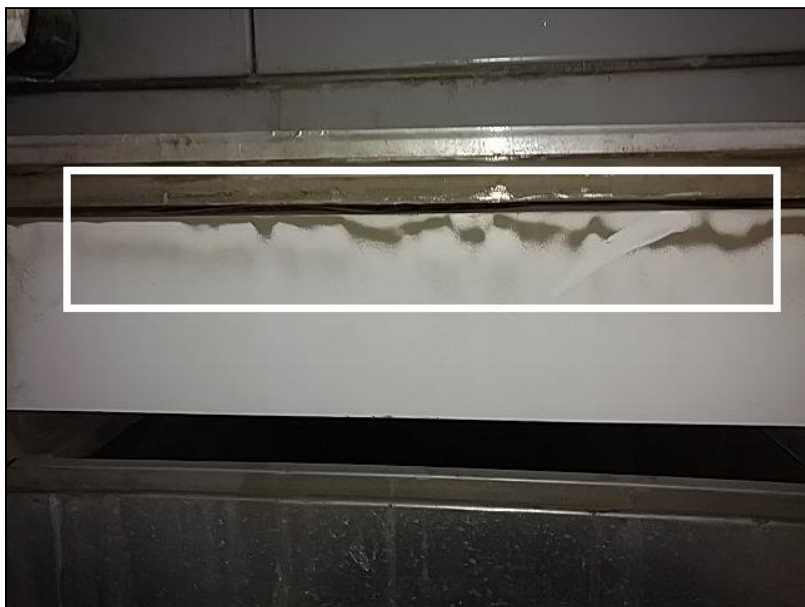
Filter

D. (6) Dust accumulation noted at filter and return plenum of the air handler for the office area. Recommend service and frequent/as necessary replacement of the filter to improve air quality.

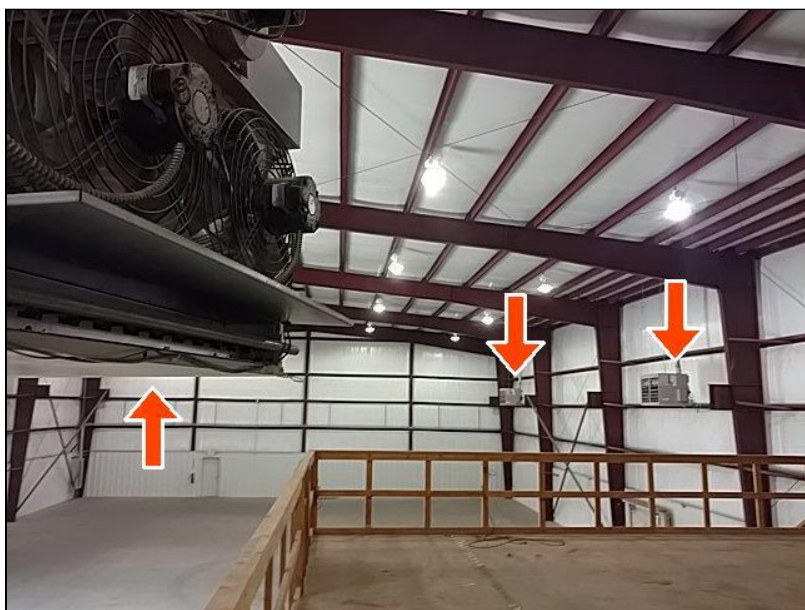
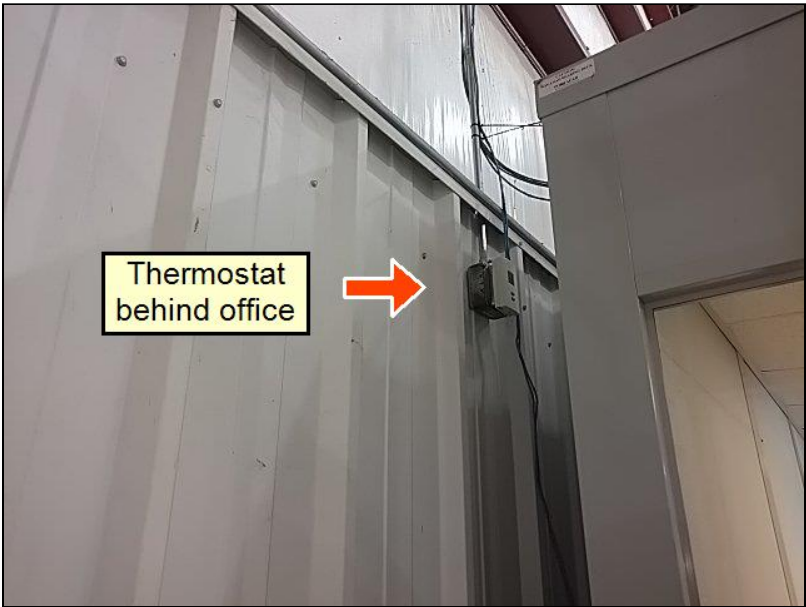
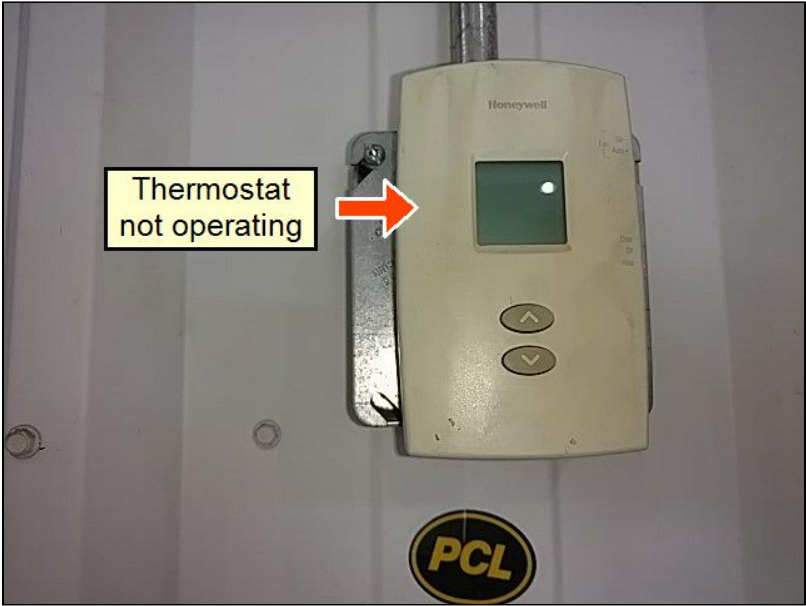
D. (7) NOTE: The warehouse is heated only with/by 3 units. Observations:

- The front left and center units did not operate
- The thermostat for the center unit did not operate
- The thermostat for the front left unit is not readily accessible
- All thermostats are inconveniently located (high). Recommend to provide ready access to the thermostats. Refer to (heating unit manufactures) guidelines

Evaluate units, thermostats and repair/replace as necessary.

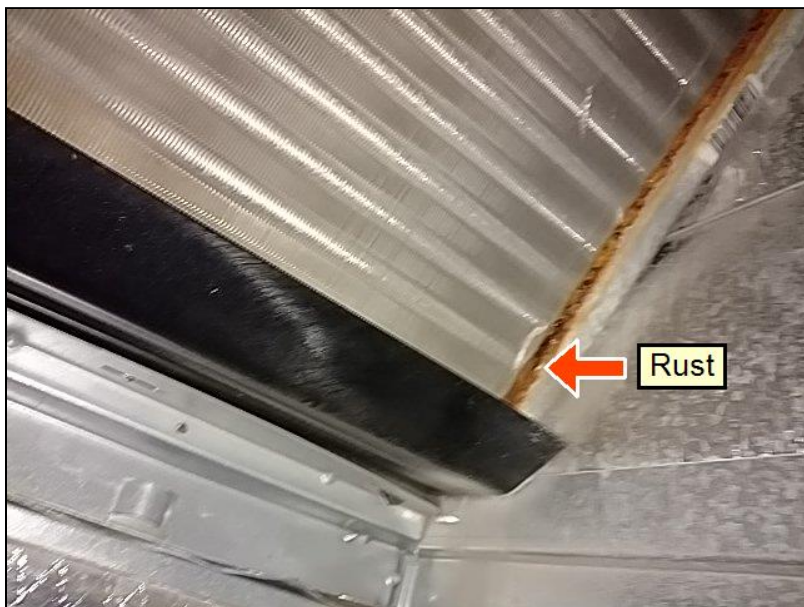
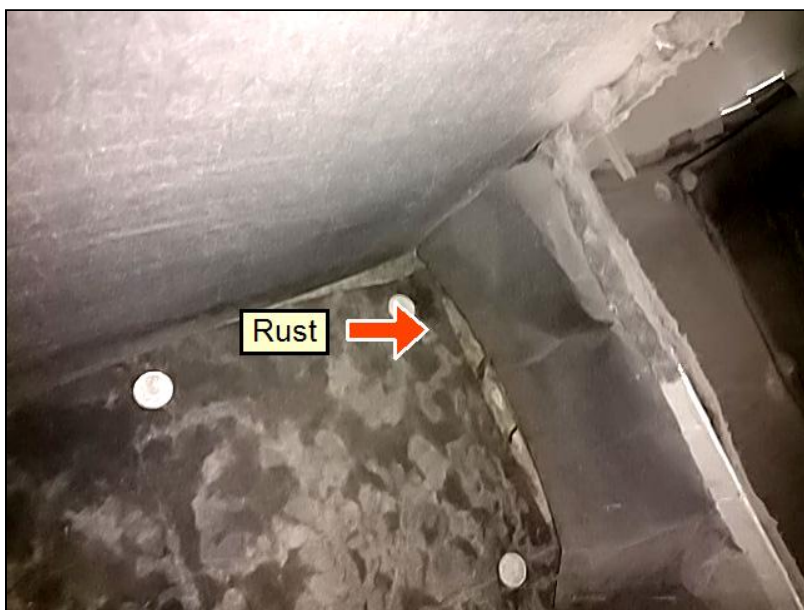
D. (8) Some rust noted at the evaporator coils and inside the return plenum. Evaluate the equipment and repairs/replacements as necessary.

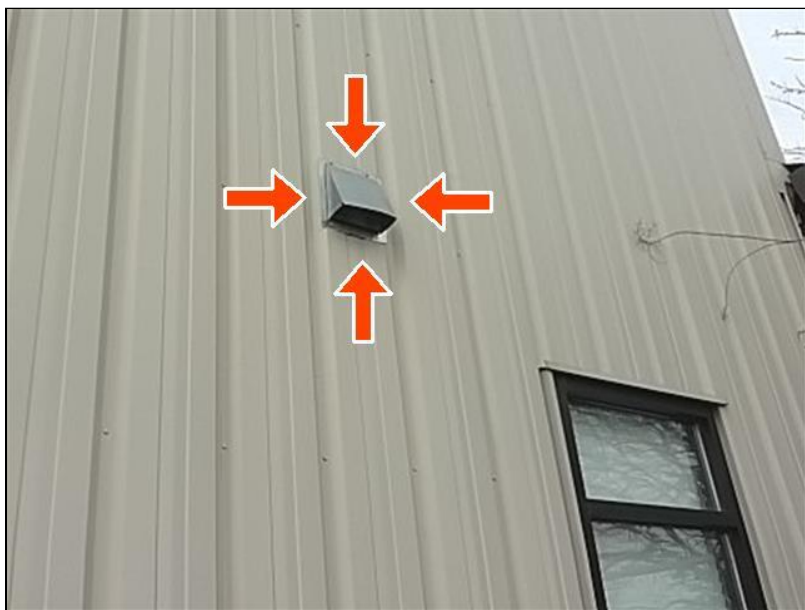
Left

E. (1) Unsealed duct cover noted at left side. Seal as necessary to avoid moisture entry.

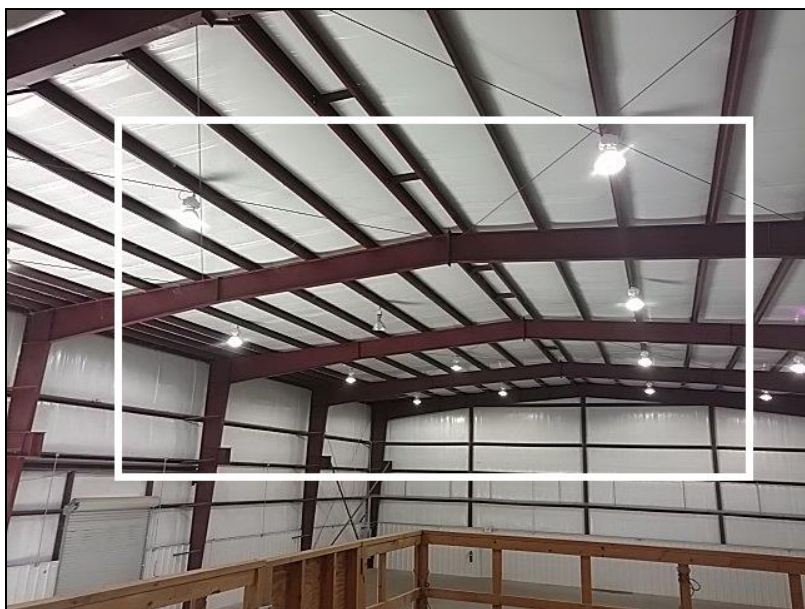
Warehouse

E. (2) NOTE: No means if ventilation noted in the warehouse. Add ventilation to improve air quality. NOTE: Typically vent requirements for warehouses are 0.05 cfm/sq.ft. (cubic ft/minute per sq.ft.) per person. Recommend to consult with a licensed contractor for further evaluation.

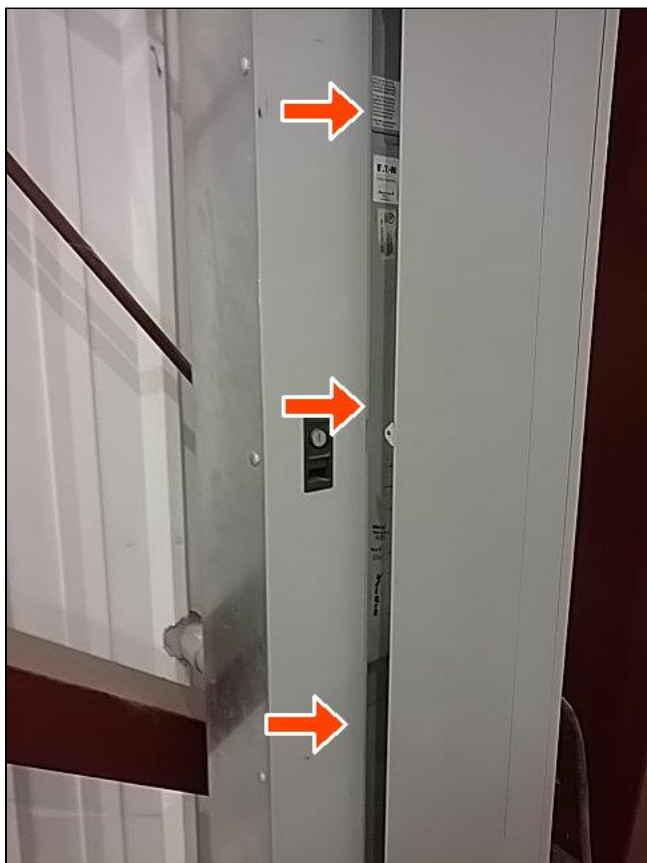
F. (2) The panel cover of the distribution panel does not close/lock. Repair as necessary.

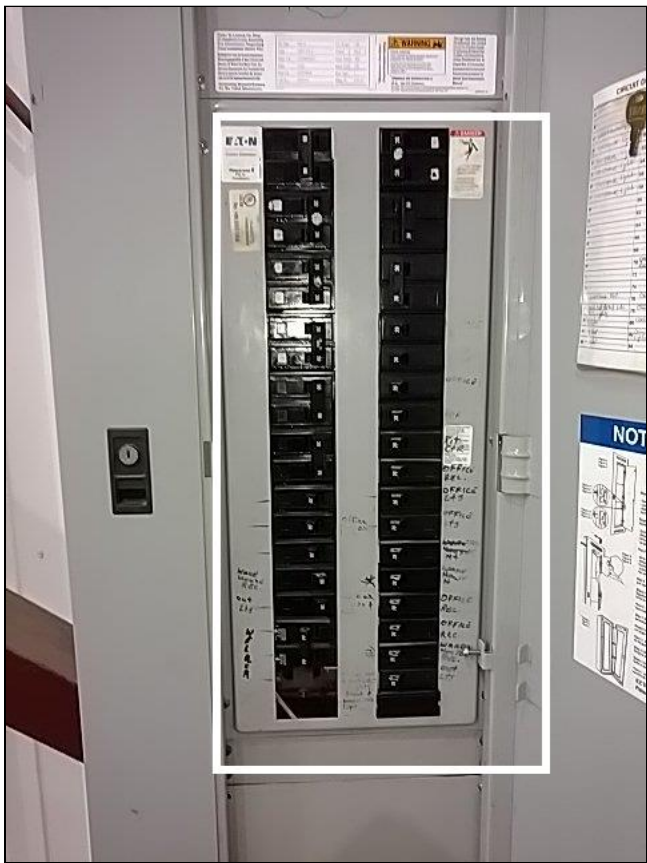
F. (3) Missing labels noted for breakers in the distribution panel. Identify circuits/purpose and label the breakers accordingly.

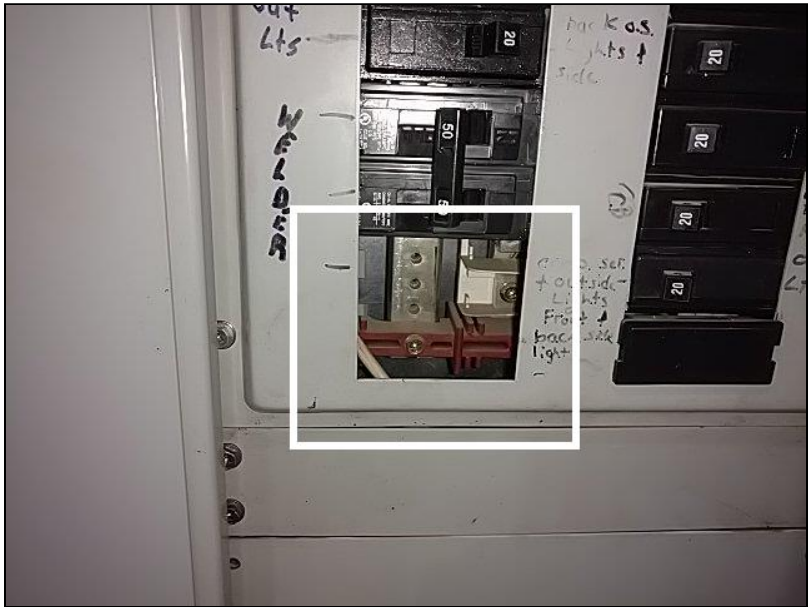
F. (4) Missing knock-out covers noted at lower left in the distribution panel. Install covers.

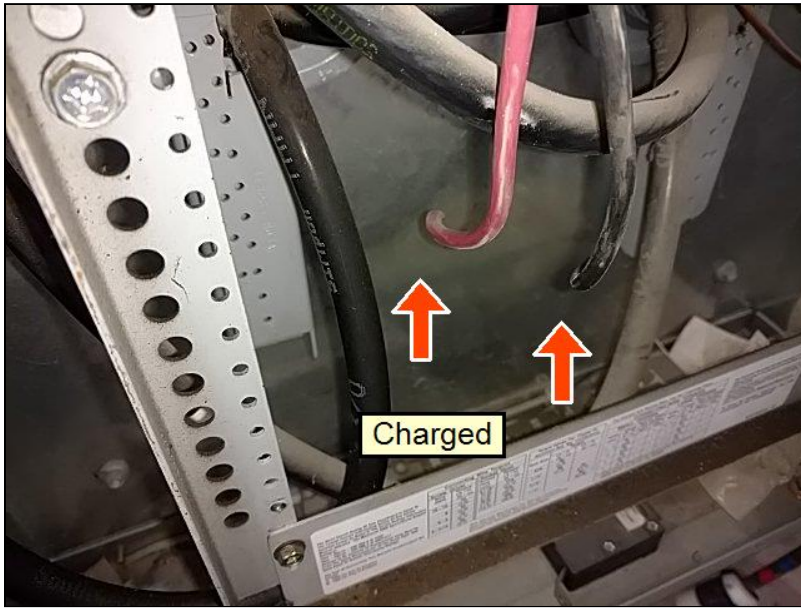
F. (5) Unprotected (and charged) conductors noted in the distribution panel. Protect/secure conductors with approved means.

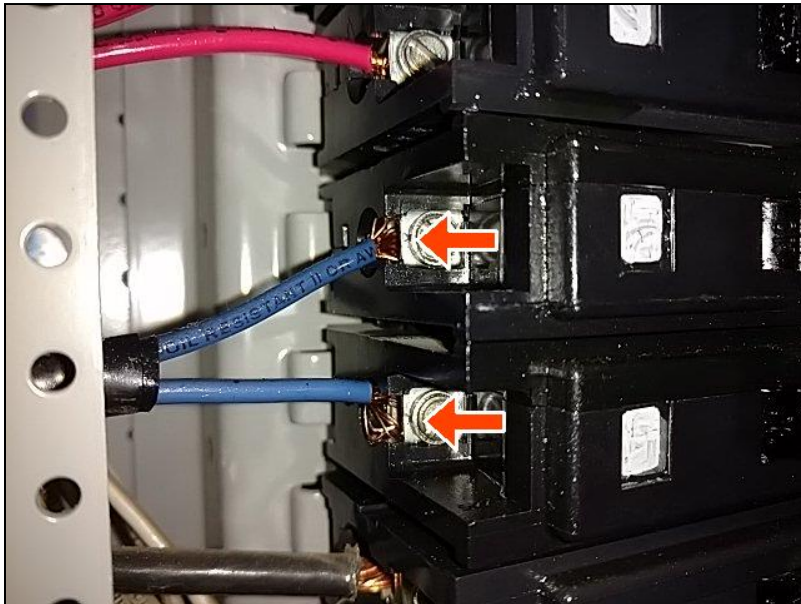
F. (6) Loose strands noted at numerous conductors at the breaker terminal(s). NOTE: Stranded wiring should be inserted completely into terminals to provide optimum contact.

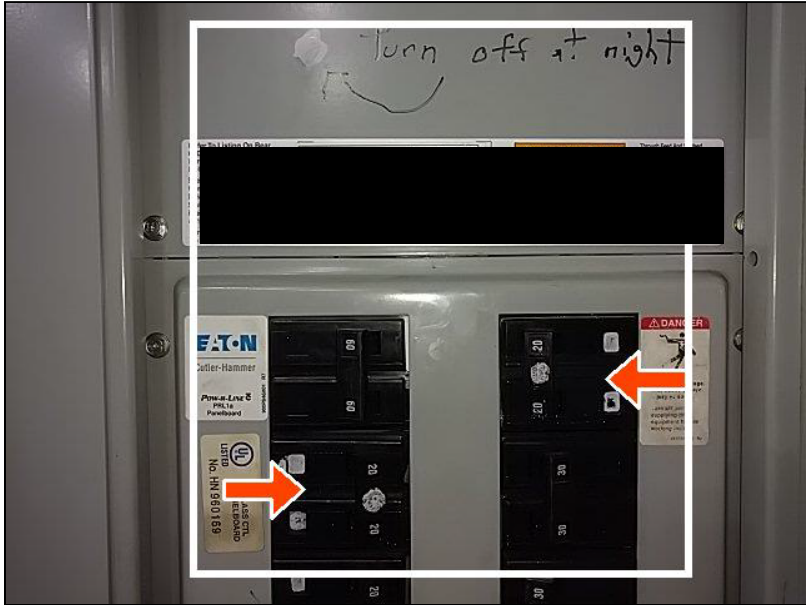
F. (7) NOTE: Some functions (i.e. warehouse lights) have to be turned on/off at breakers in the distribution panel. Recommend to install switches at conveniently accessible locations.

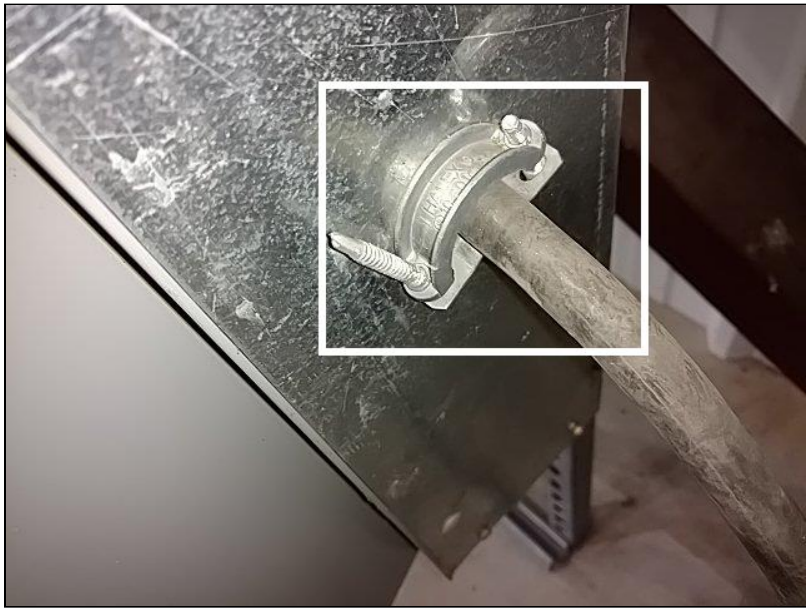
F. (8) Loose cable/extension noted at right side of the distribution panel. Secure cable with appropriately sized clamp.

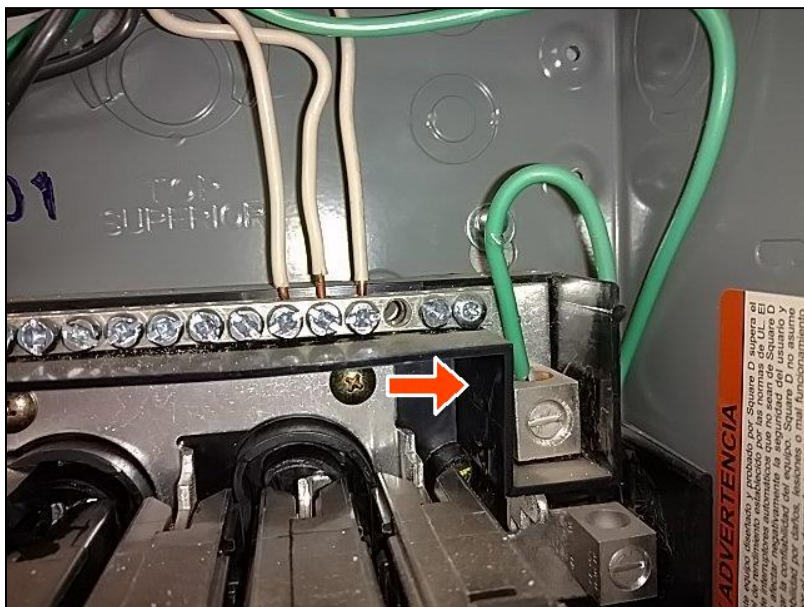
Sub-panel

F. (9) Improper grounding noted at the sub-panel in the warehouse office. NOTE: Grounded conductors (neutral) wiring should be separated from the ground conductor (ground wire) downstream of the disconnect. Repair as necessary.

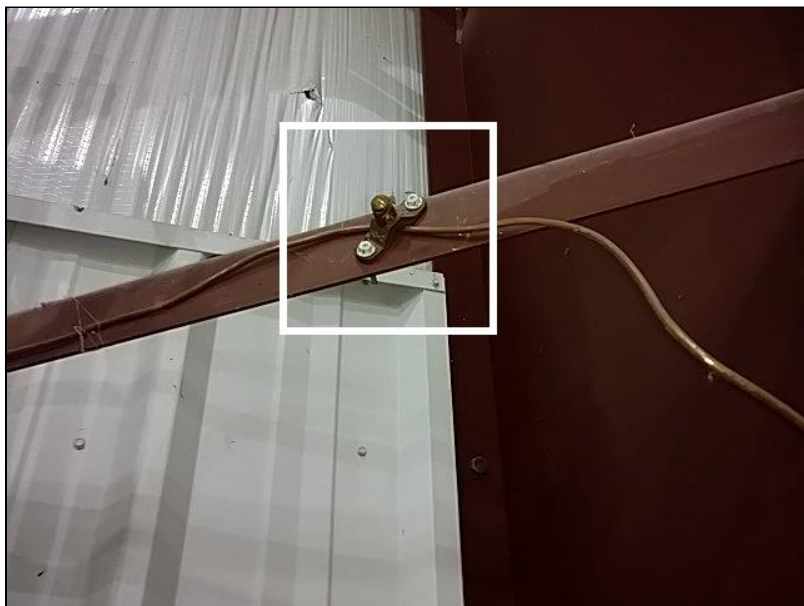
F. (10) Improperly sized (too small) ground conductor (ground wire) suspected. NOTE: Ground conductors should be sized based on the supply size of service cable. Evaluate conductors size and replace if necessary.

ALSO: The clamp does not appear to be approved for the attachment application and the ground conductor (ground wire) should connect directly on bare metal. Evaluate attachment and repair as necessary.

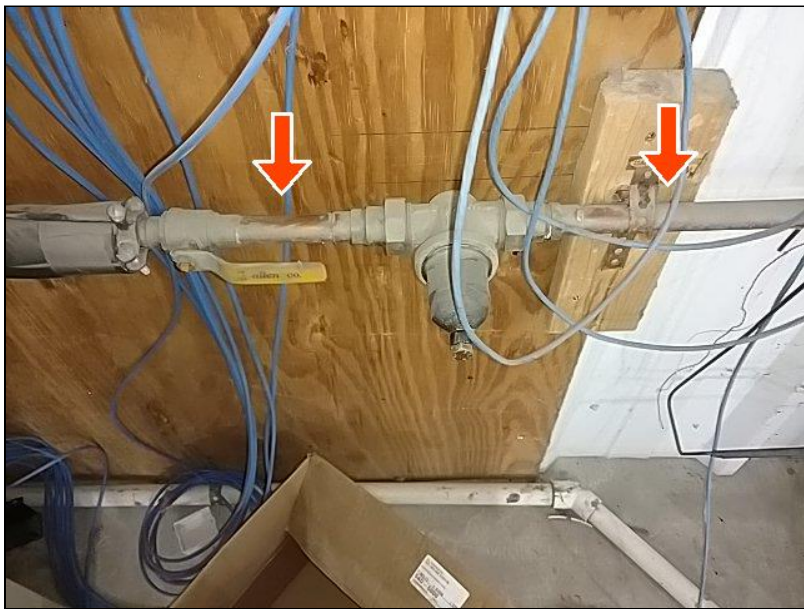
Pressure reduction valve

F. (11) Missing bonding jumper noted around installed equipment (i.e. pressure reduction valve). NOTE: The copper water supply/distribution system should be bonded around equipment installed in the system. Repair as necessary to include the whole copper water line supply/distribution system into the grounding system.

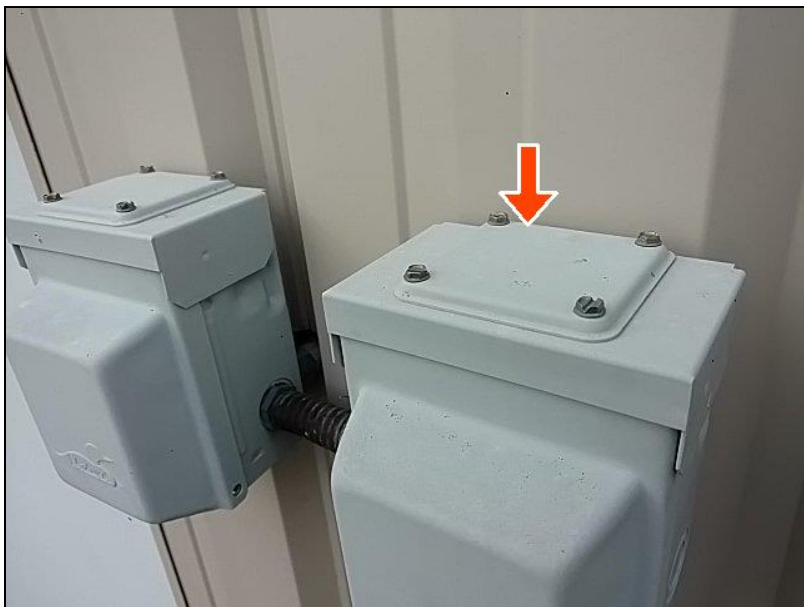
Exterior, left

G. (1) Loose disconnect panels noted at left side. Secure equipment as necessary.

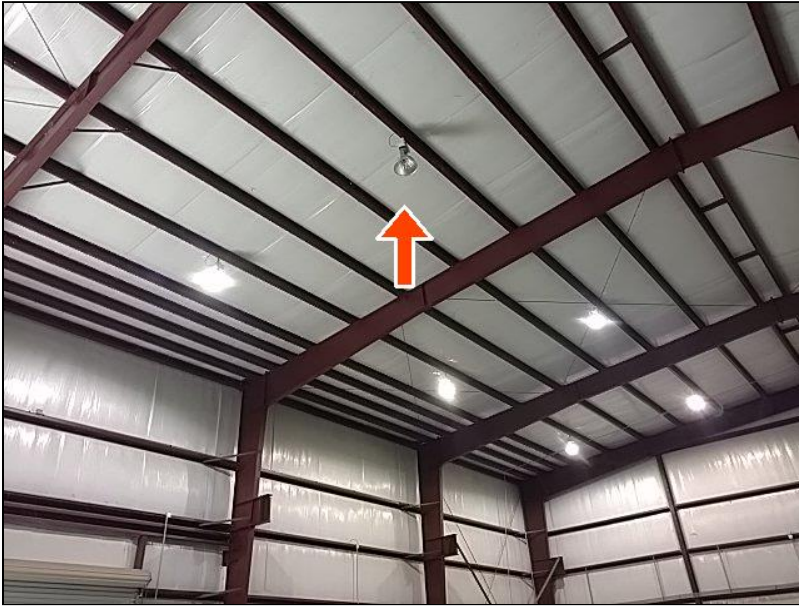
This location: Warehouse lights

G. (2) Not operating light fixtures noted at numerous locations and observed in the warehouse, warehouse office and front left office. Replace light bulbs/evaluate circuits. Replace/repair as necessary.

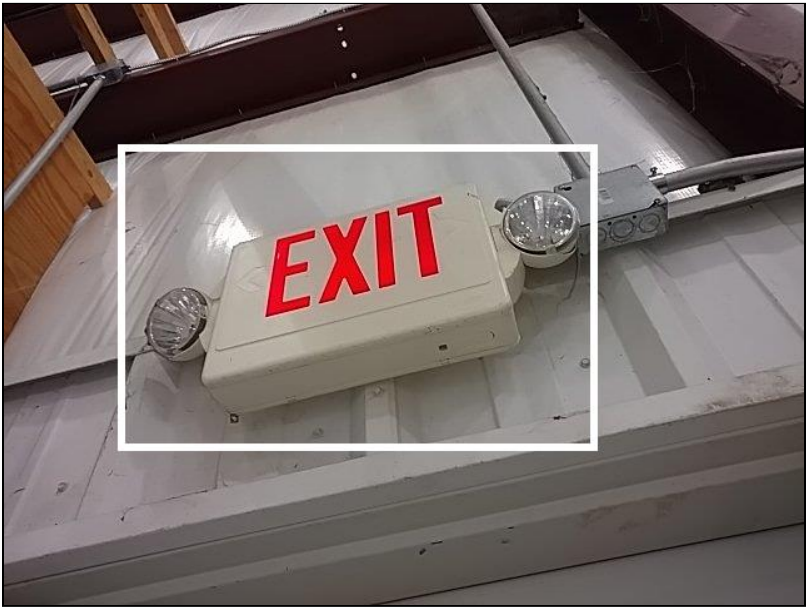
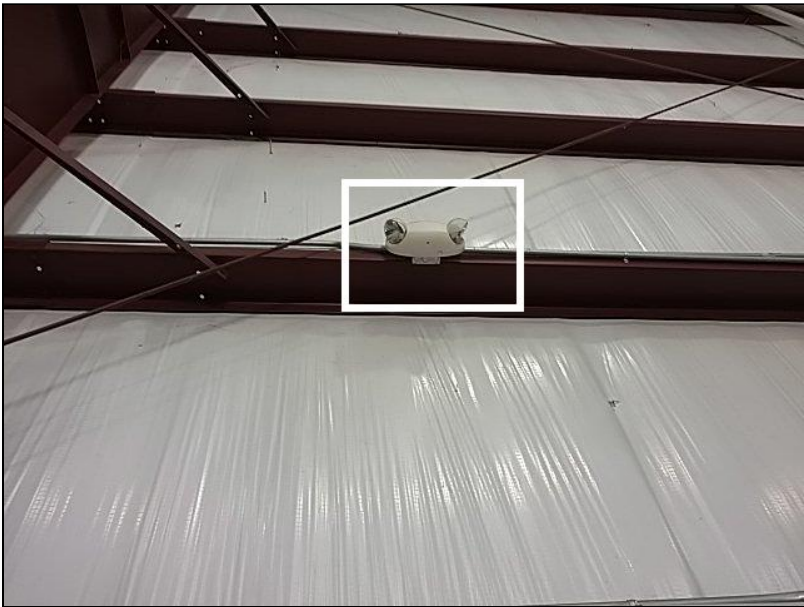
B. None of the emergency lights operated. Recommend evaluation and repairs/replacements as necessary.

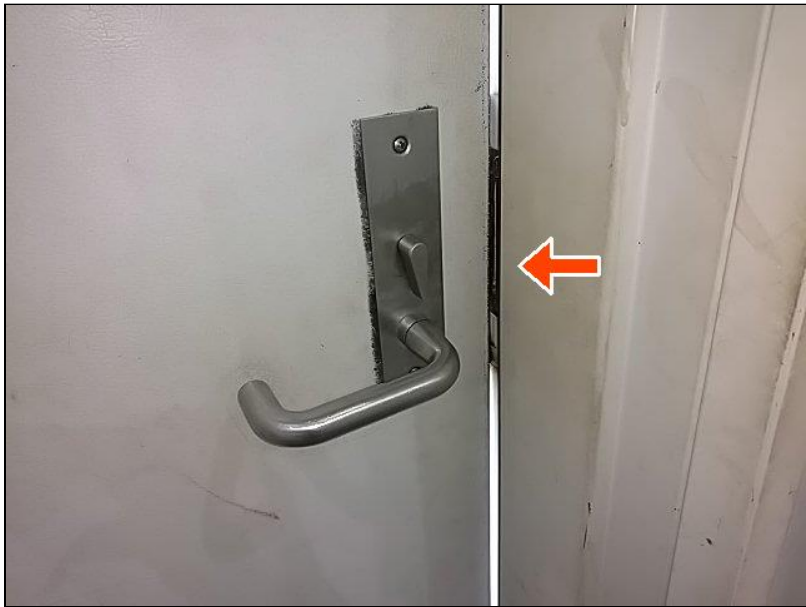
Left exit door

A. (1) The left exit door binds. Adjust as necessary.
