Property Condition Assessment

Champia Real Estate Inspections, LLC

Date: 3/29/2018	Time: 09:00:00 AM	Report ID: 31646
Property: [REDACTED]	Customer: [REDACTED]	Real Estate Professional: [REDACTED]

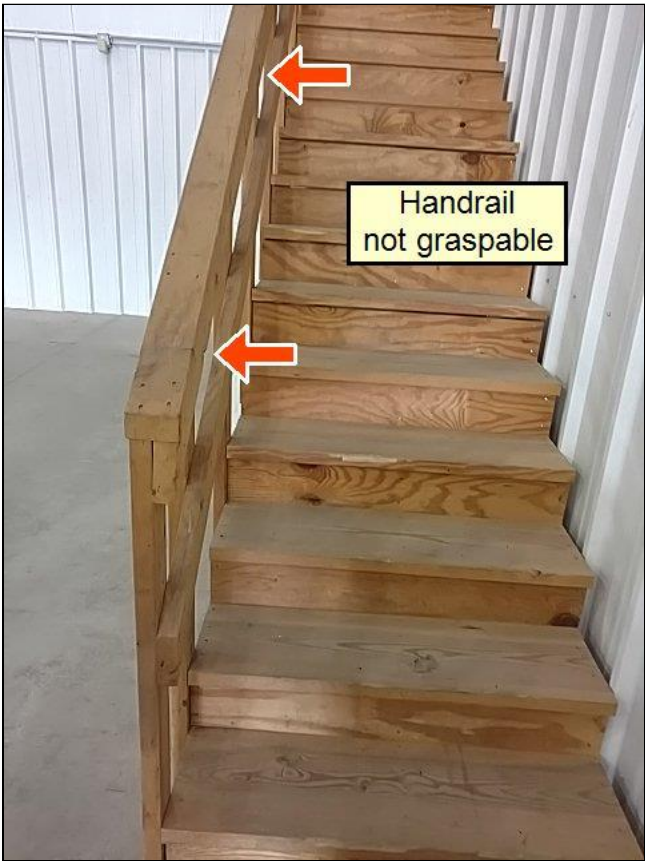
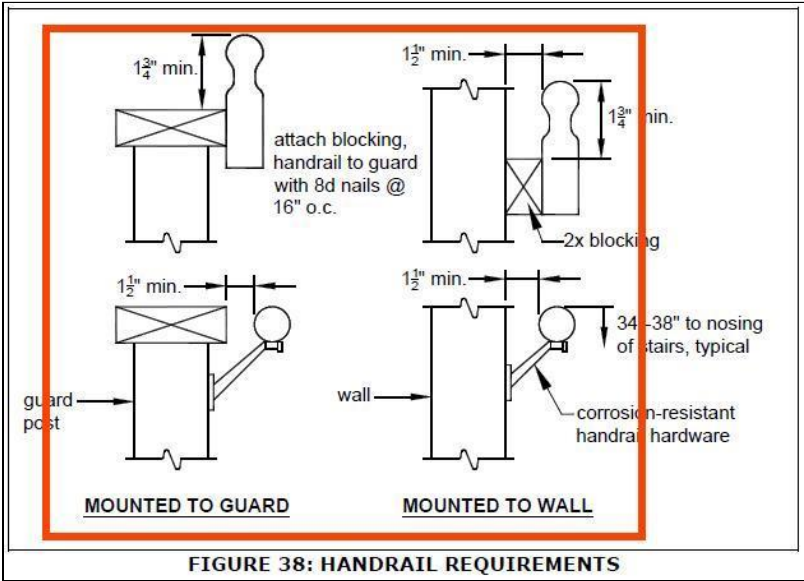
Loft stairs

B. (1) Handrail not graspable at loft stairs. NOTE: Handrails should be graspable. Install appropriate handrail design.

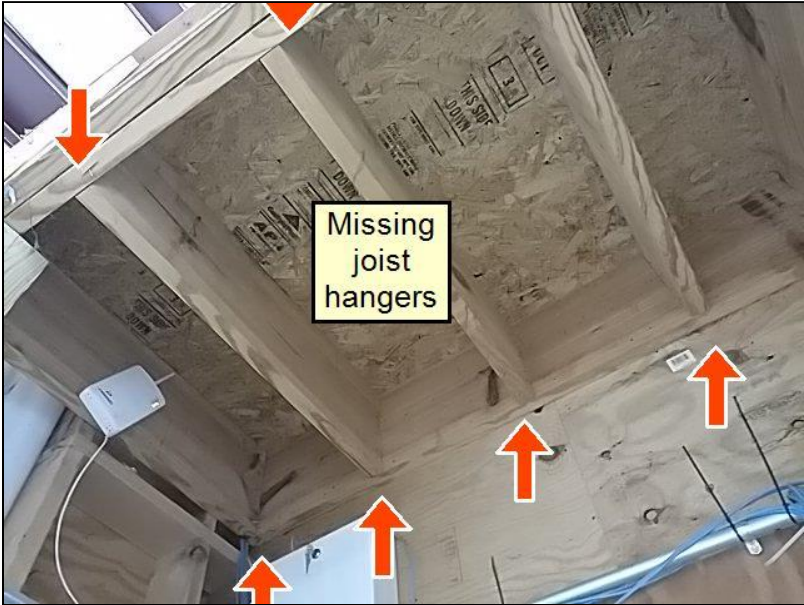
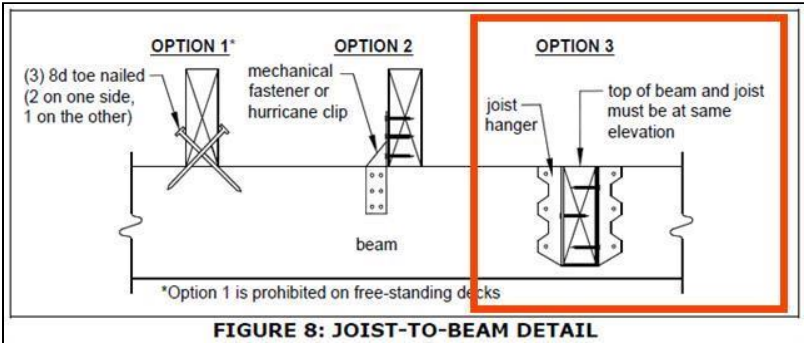
Loft landing

B. (2) Missing joist hangers noted at loft stair landing. NOTE: Joists should be secured with joist hangers. Install joist hangers with approved fasteners.

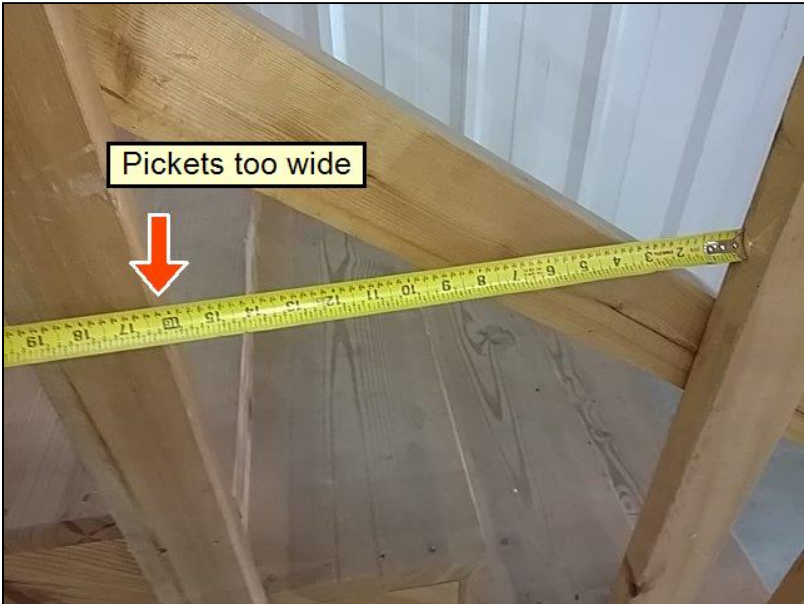
Loft stair railing

B. (3) Pickets too wide at loft stair railing. NOTE: Pickets at stair railings should not spaced wider than 4 3/8" apart. Repair as necessary.

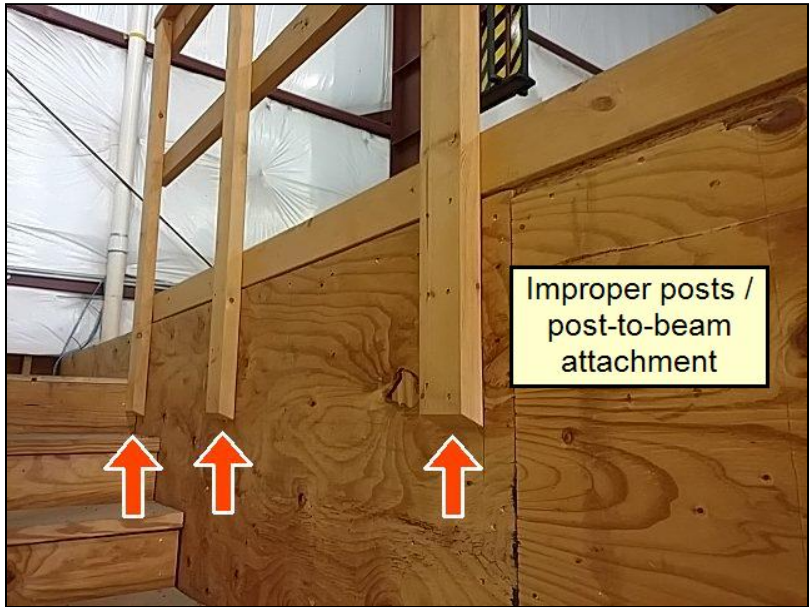
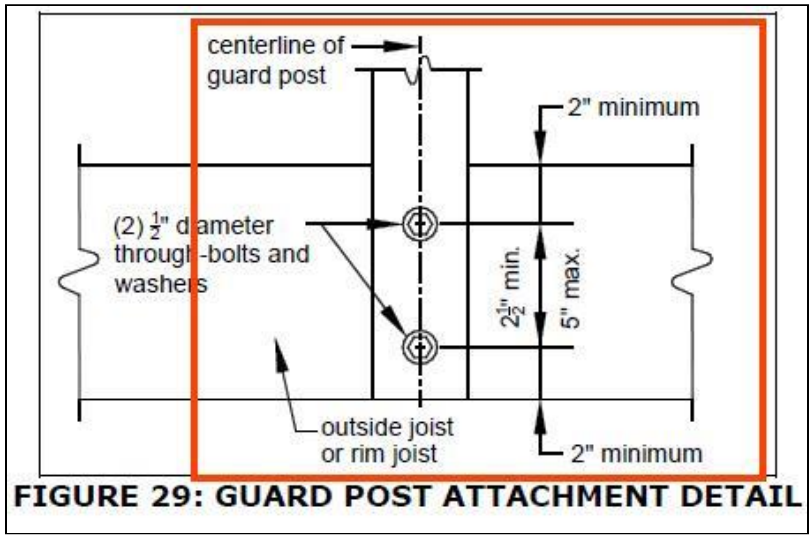
Loft guard rail attachment

B. (4) Improper post-to-beam/rim board attachment. NOTE: Posts (i.e. 4x4") should be attached full-width with 2 x 1/2" bolts (and washers). Repair as necessary and ensure proper structure at interior side.

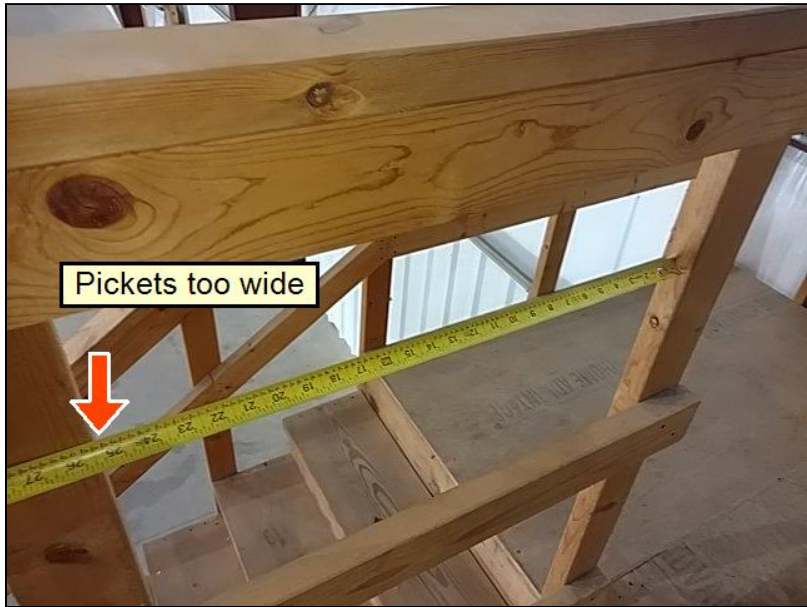
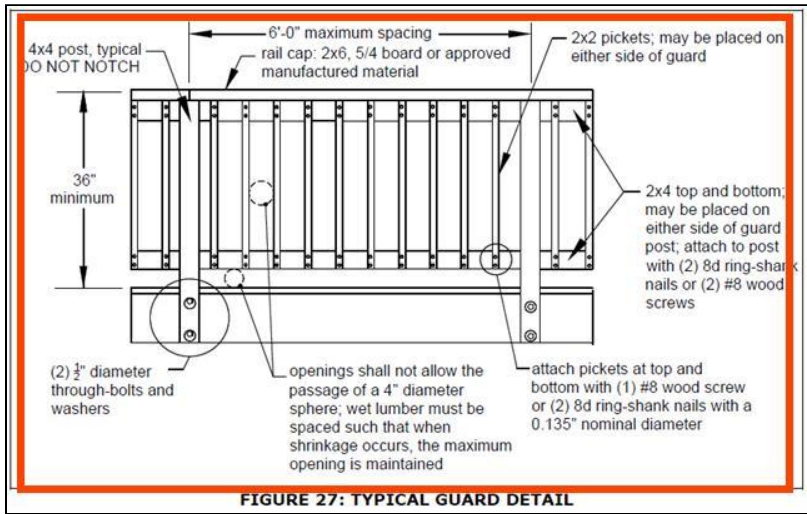
Loft guard rail

B. (5) Pickets too wide at loft guard rail. NOTE: Pickets at guard railings should not spaced wider than 4" apart. Repair as necessary.

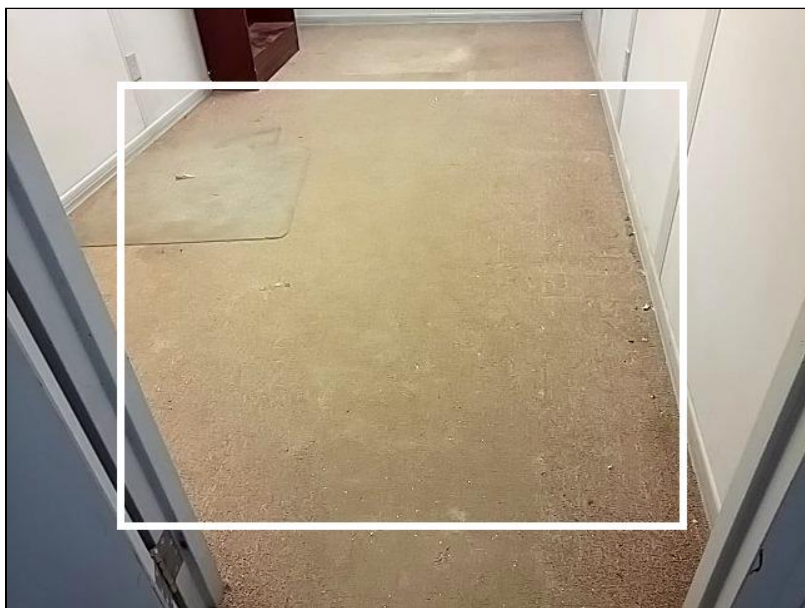
Warehouse office

B. (6) Damaged/worn flooring noted at warehouse office. Recommend replacement.

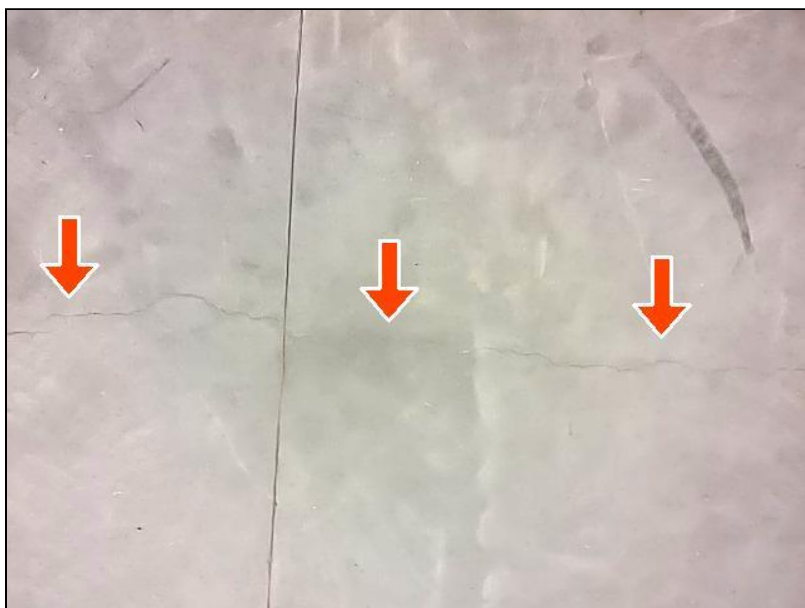
This location: Rear right

B. (7) Cracks noted at warehouse flooring at numerous locations. Monitor and repair as necessary.

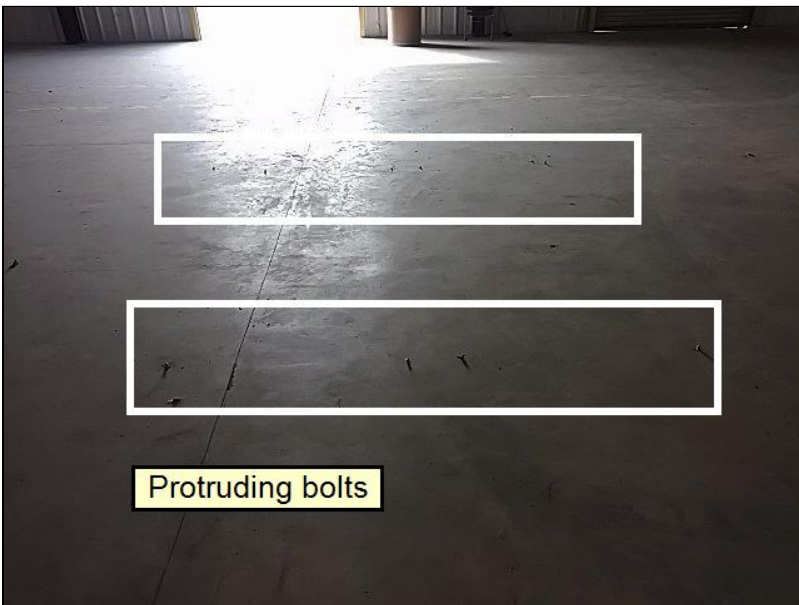
Warehouse, front center

B. (8) Protruding bolts noted at numerous locations at the warehouse floor. Remove bolts and seal openings.

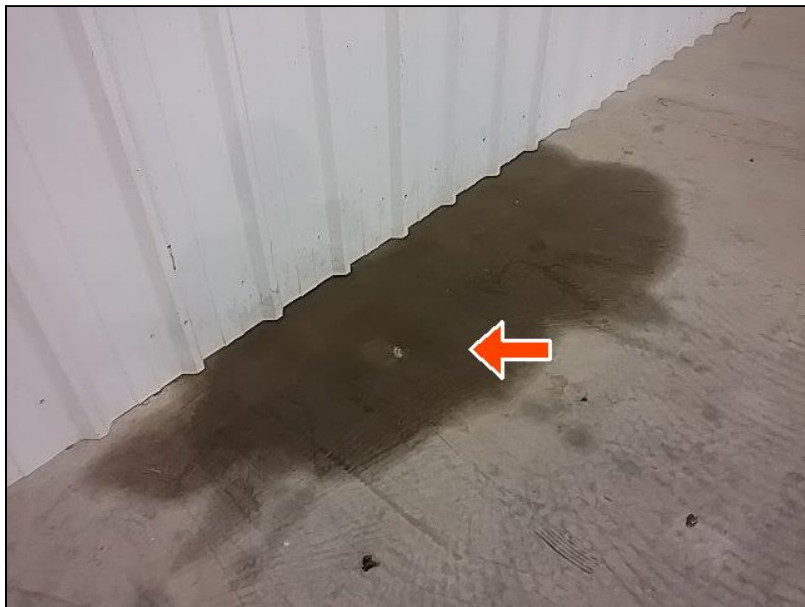
Warehouse, right

B. (9) Oily substance noted at warehouse at right side. Recommend Phase I inspection. Clean with approved materials and dispose at approved locations.

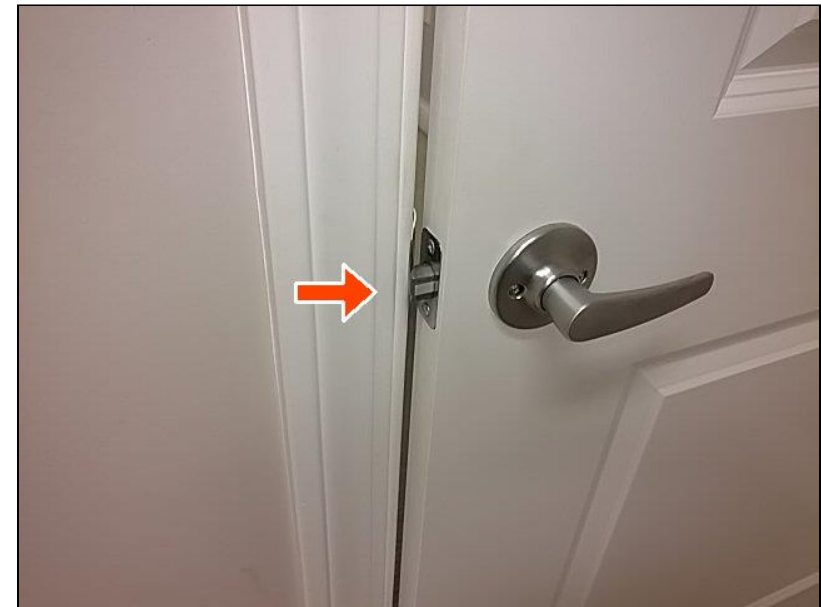
Rear right office

A. Door at rear right office binds. Adjust as necessary.

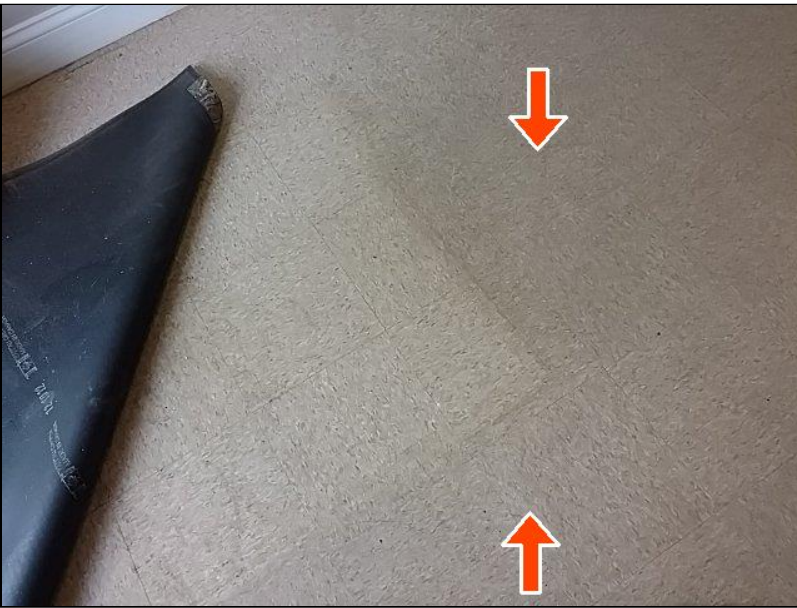
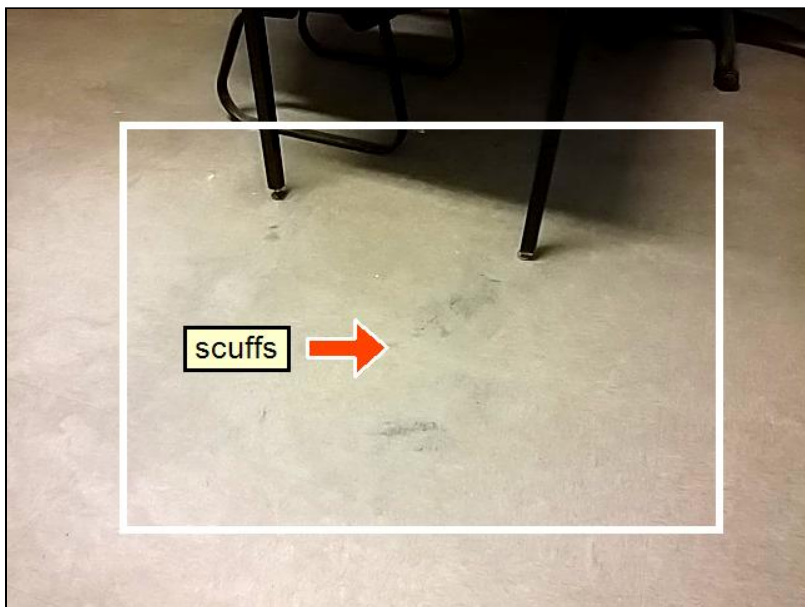
B. Worn flooring noted throughout the office area. Refer to images for typical locations. Clean/repair/replace as necessary.

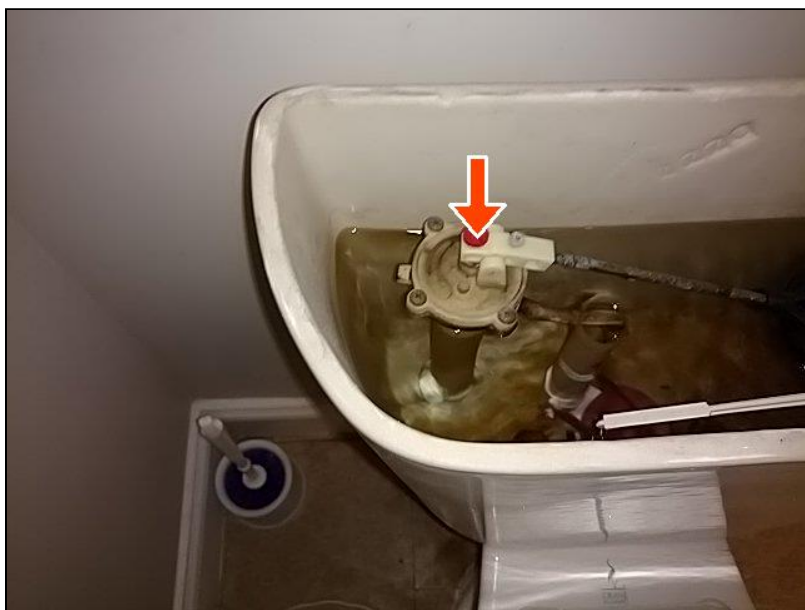
Women's bathroom

D. (1) The toilet flush tank at the women's bathroom runs continuously (the fill valve appears to be damaged). **NOTE:** Inspector closed supply valve after inspection.

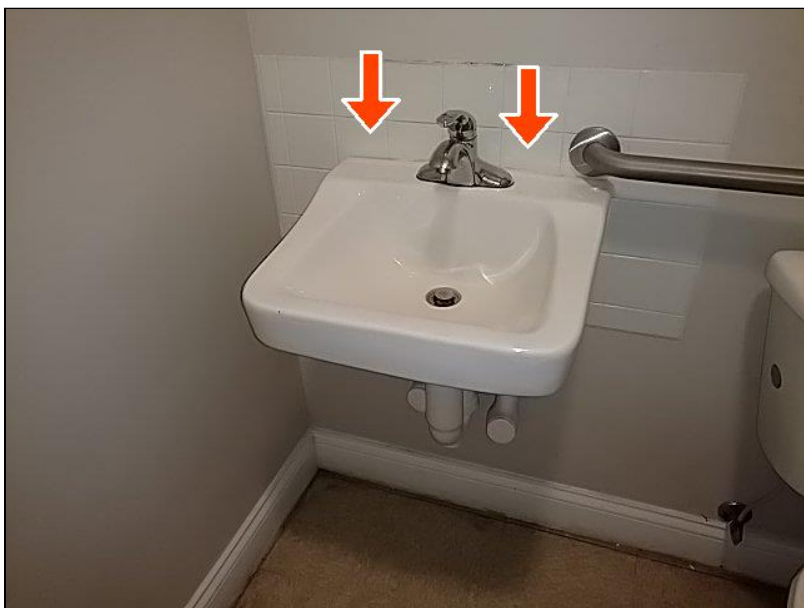
This location: Men's bathroom

D. (2) Loose sink(s) noted at women's/men's bathroom(s). Secure sinks as necessary.

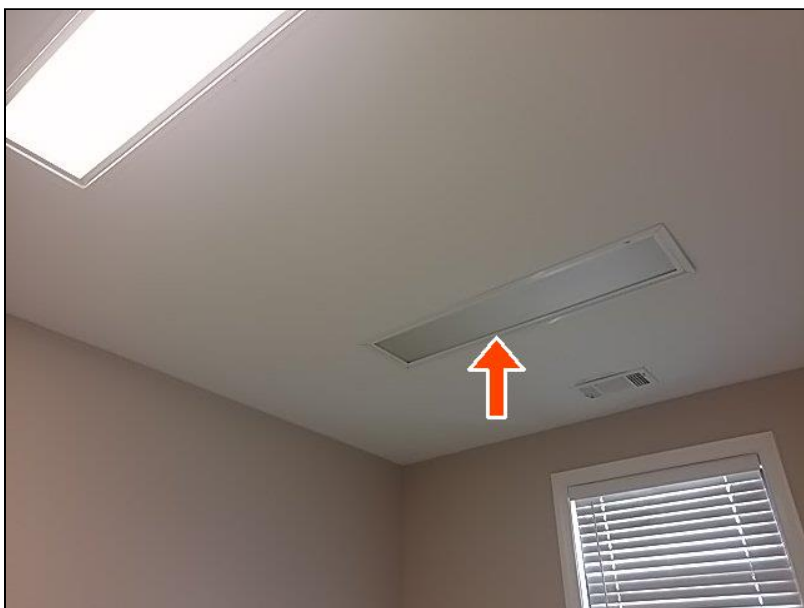
Rear left office

E. Not operating light fixture noted at rear left office. Replace light bulbs/evaluate circuits. Replace/repair as necessary.
