Property Condition Assessment

Champia Real Estate Inspections, LLC

Date: 3/29/2018	Time: 09:00:00 AM	Report ID: 31646
Property: [REDACTED]	Customer: [REDACTED]	Real Estate Professional: [REDACTED]

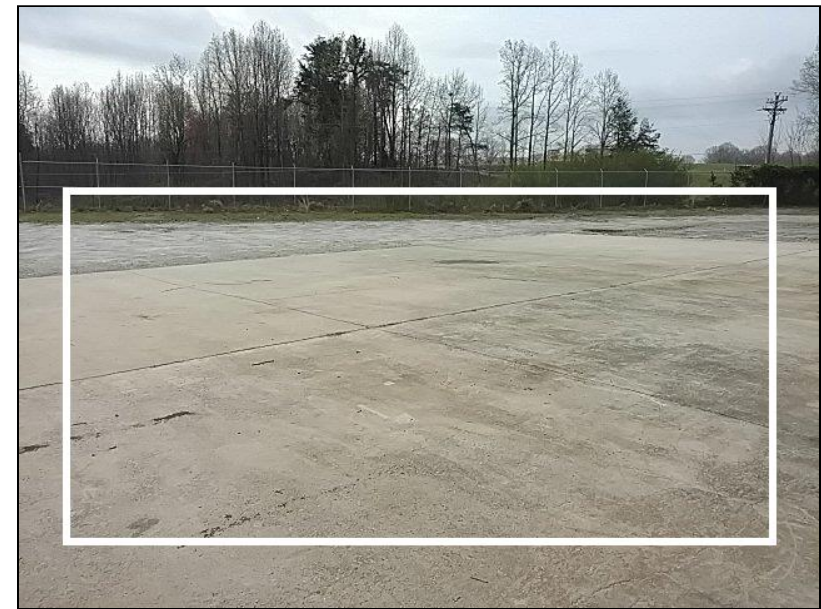
**D.** Cracks noted at rear driveway. Some of the parking area is not paved. Repair/replace as necessary.

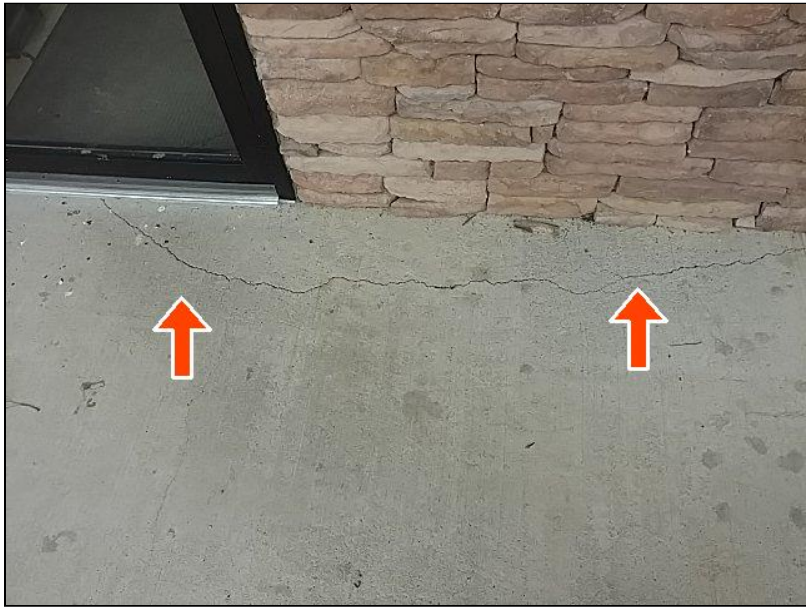
Front

E. (2) Cracks noted at front walkway. Recommend to seal cracks/repair/replace as necessary to avoid moisture entry.

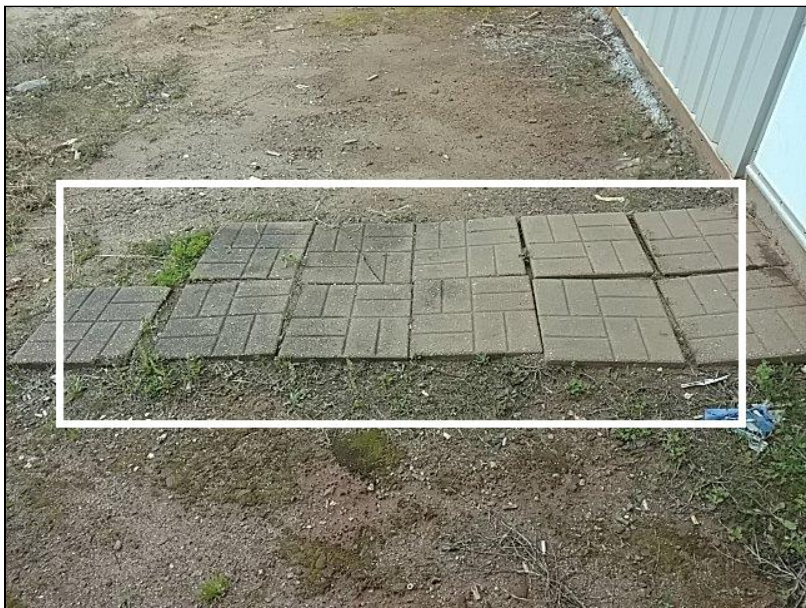
Right

E. (3) Displaced/damaged pavers noted at right side driveway. Repair/replace as necessary to avoid trip hazard.

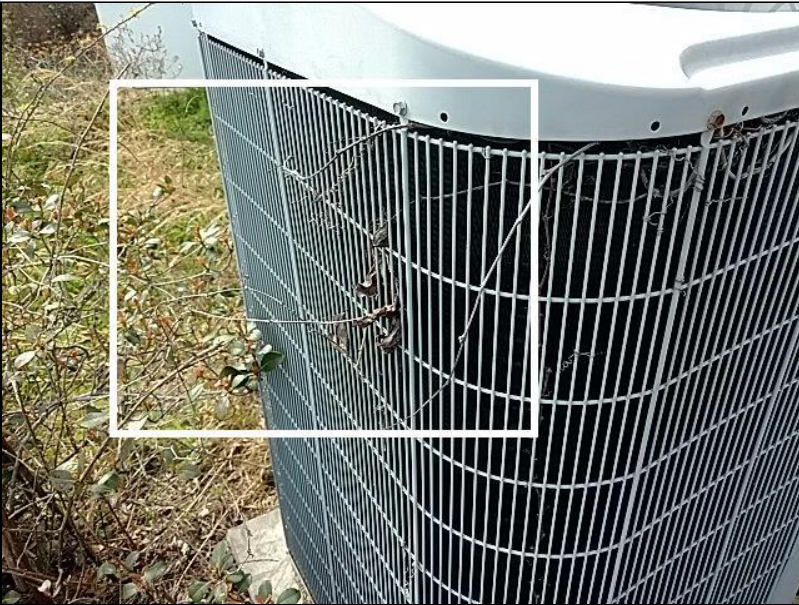
AC unit

D. (3) Intrusion of vines noted at the AC screen. NOTE: AV screens should be kept clear of intrusions to maximize performance.

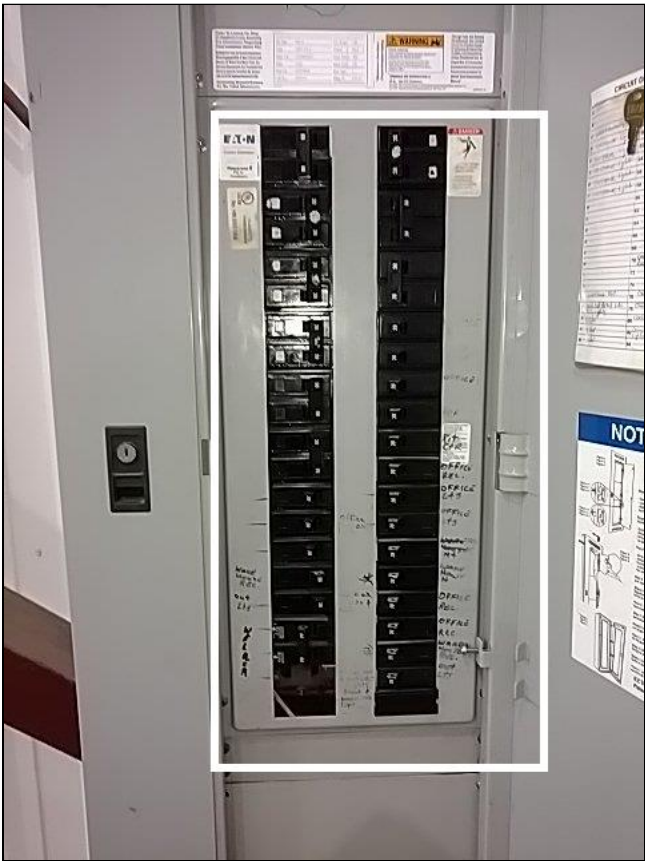
F. (3) Missing labels noted for breakers in the distribution panel. Identify circuits/purpose and label the breakers accordingly.

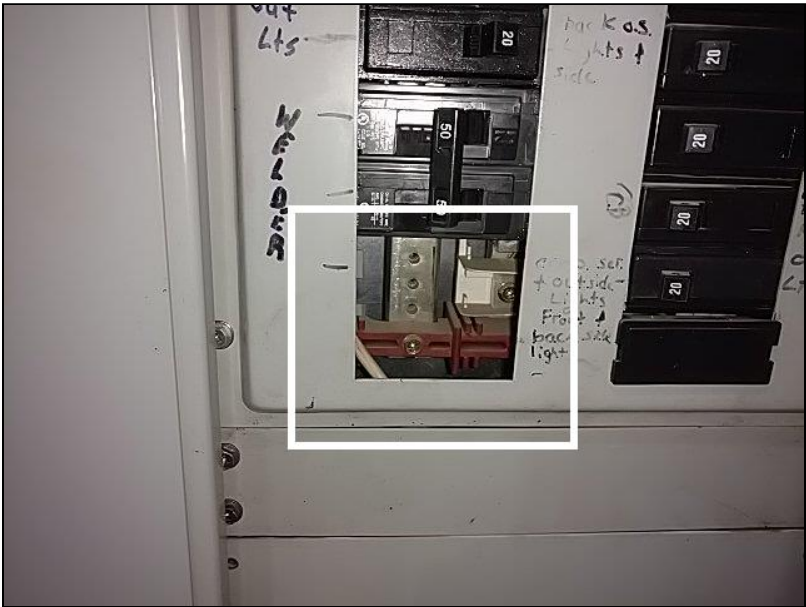
F. (4) Missing knock-out covers noted at lower left in the distribution panel. Install covers.

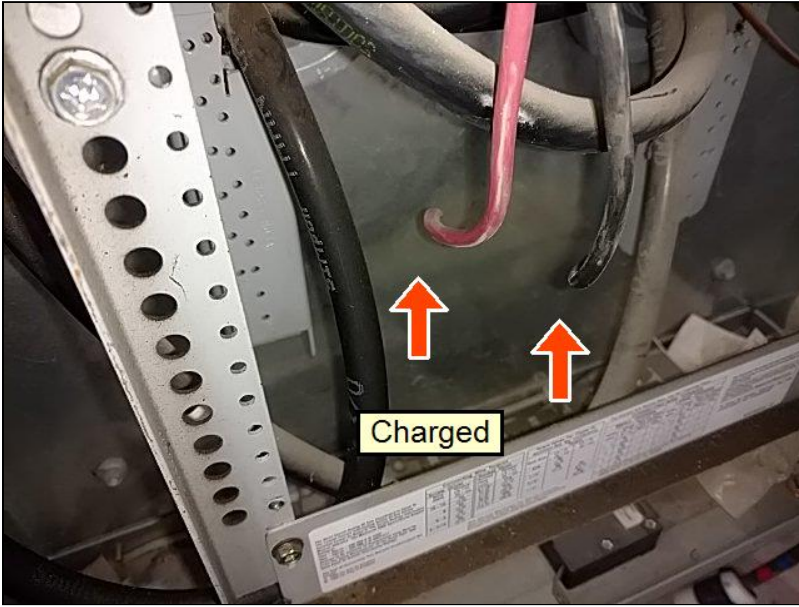
F. (5) Unprotected (and charged) conductors noted in the distribution panel. Protect/secure conductors with approved means.

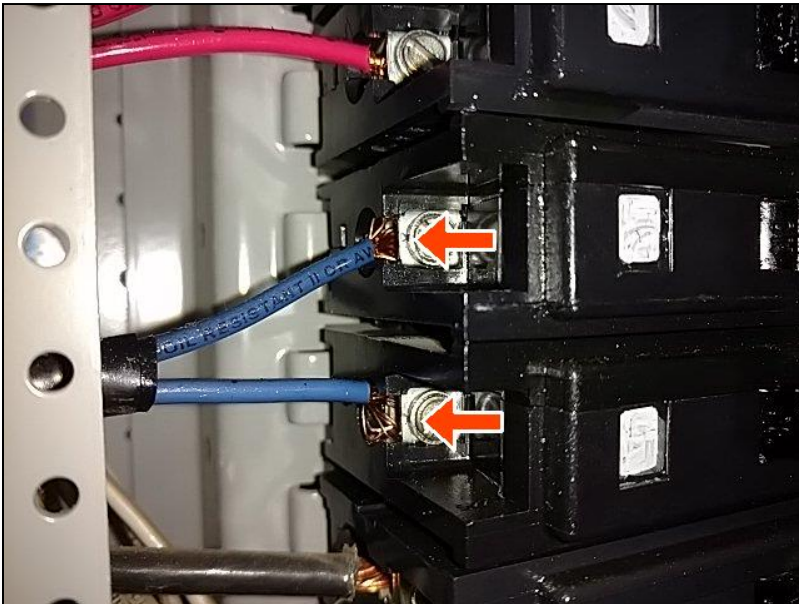
F. (6) Loose strands noted at numerous conductors at the breaker terminal(s). NOTE: Stranded wiring should be inserted completely into terminals to provide optimum contact.

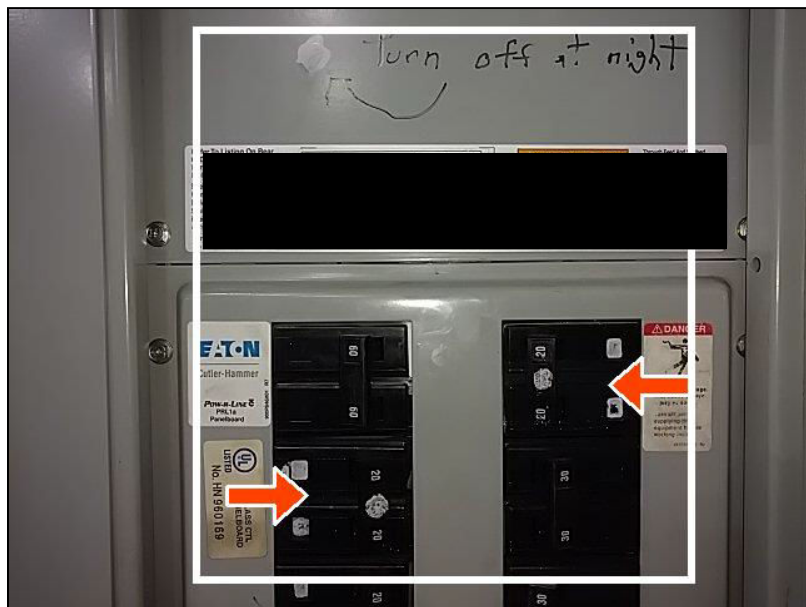
F. (7) NOTE: Some functions (i.e. warehouse lights) have to be turned on/off at breakers in the distribution panel. Recommend to install switches at conveniently accessible locations.

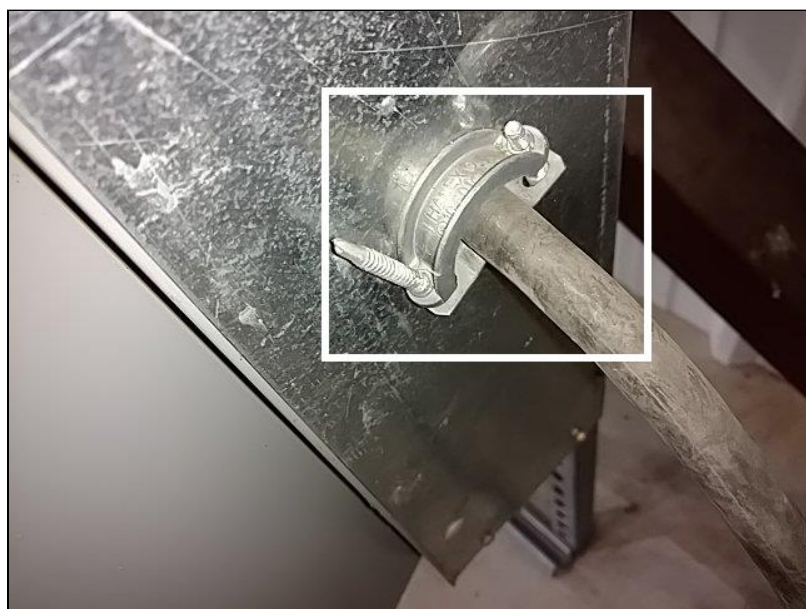
F. (8) Loose cable/extension noted at right side of the distribution panel. Secure cable with appropriately sized clamp.

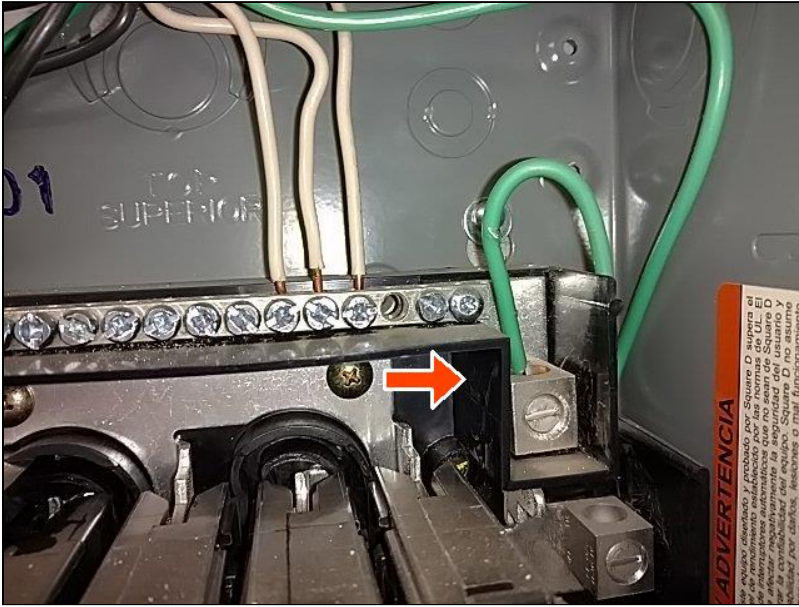
Sub-panel

F. (9) Improper grounding noted at the sub-panel in the warehouse office. NOTE: Grounded conductors (neutral) wiring should be separated from the ground conductor (ground wire) downstream of the disconnect. Repair as necessary.

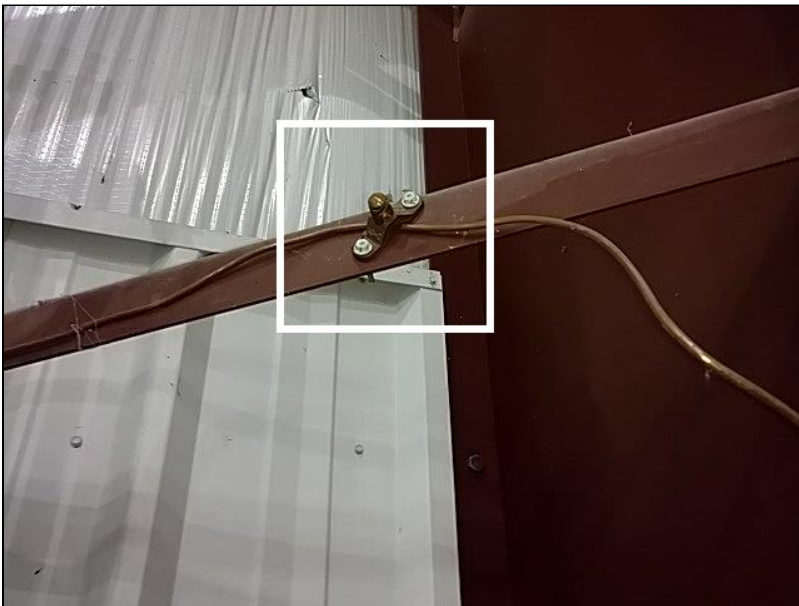
F. (10) Improperly sized (too small) ground conductor (ground wire) suspected. NOTE: Ground conductors should be sized based on the supply size of service cable. Evaluate conductors size and replace if necessary.

ALSO: The clamp does not appear to be approved for the attachment application and the ground conductor (ground wire) should connect directly on bare metal. Evaluate attachment and repair as necessary.

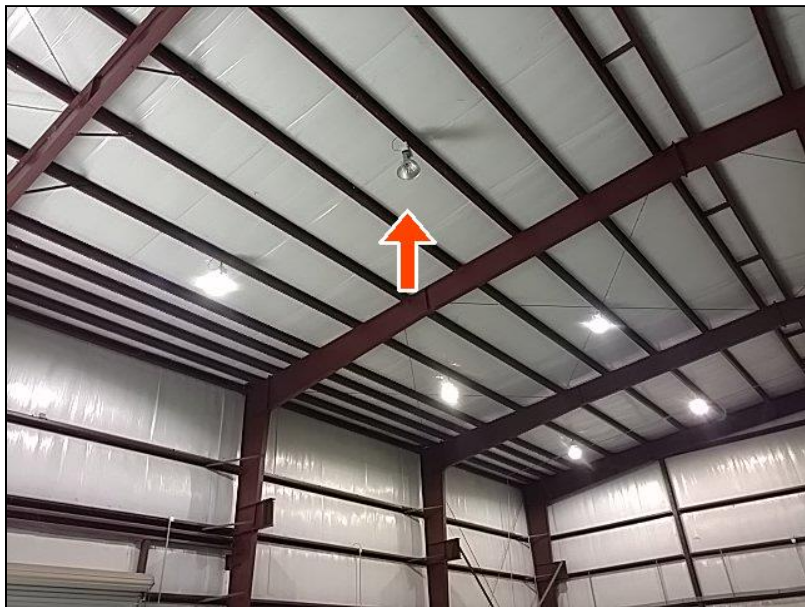
This location: Warehouse lights

G. (2) Not operating light fixtures noted at numerous locations and observed in the warehouse, warehouse office and front left office. Replace light bulbs/evaluate circuits. Replace/repair as necessary.

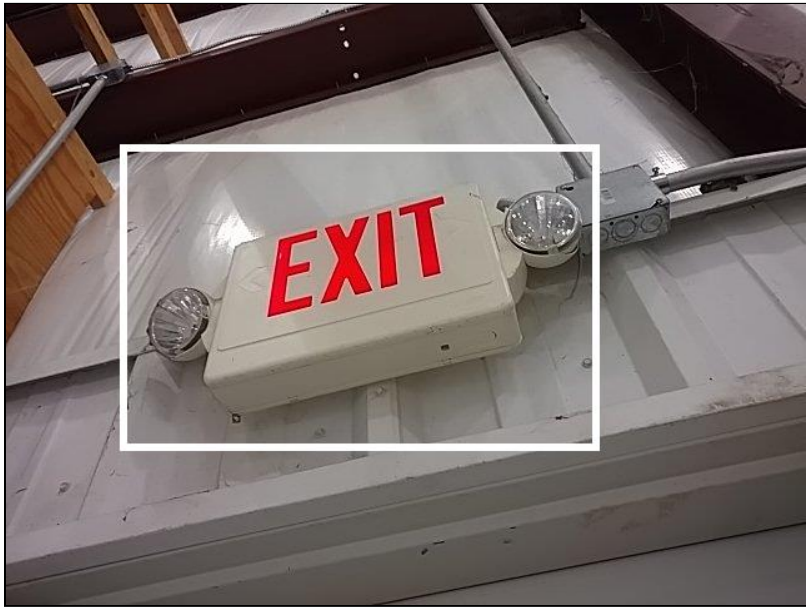
This location: Front left

B. None of the emergency lights operated. Recommend evaluation and repairs/replacements as necessary.

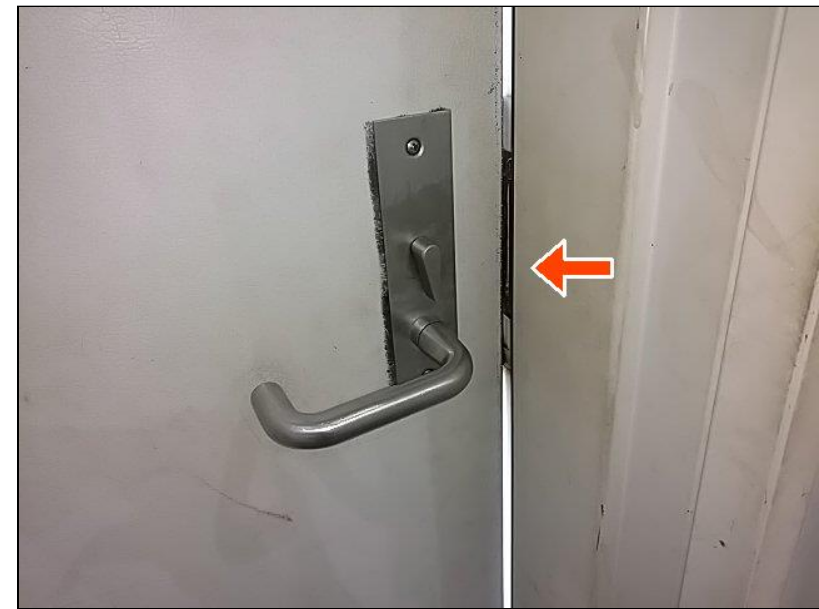
Left exit door

A. (1) The left exit door binds. Adjust as necessary.

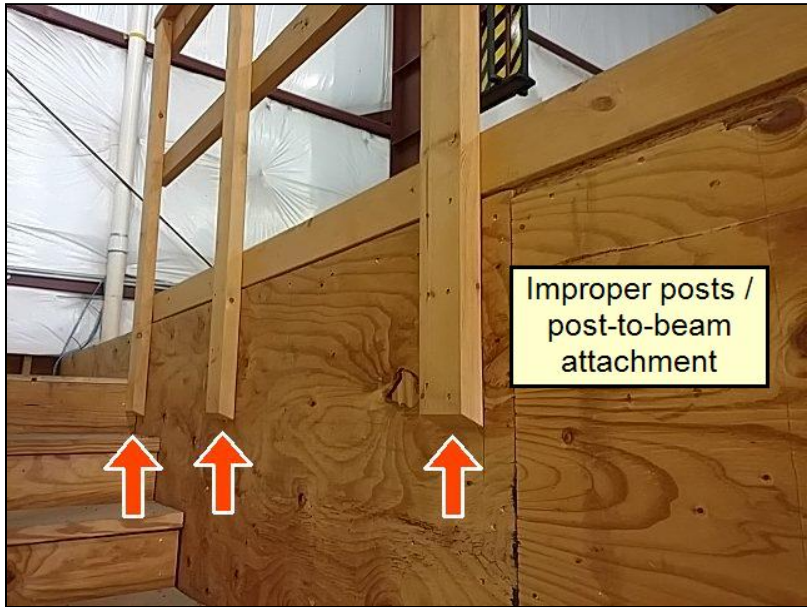
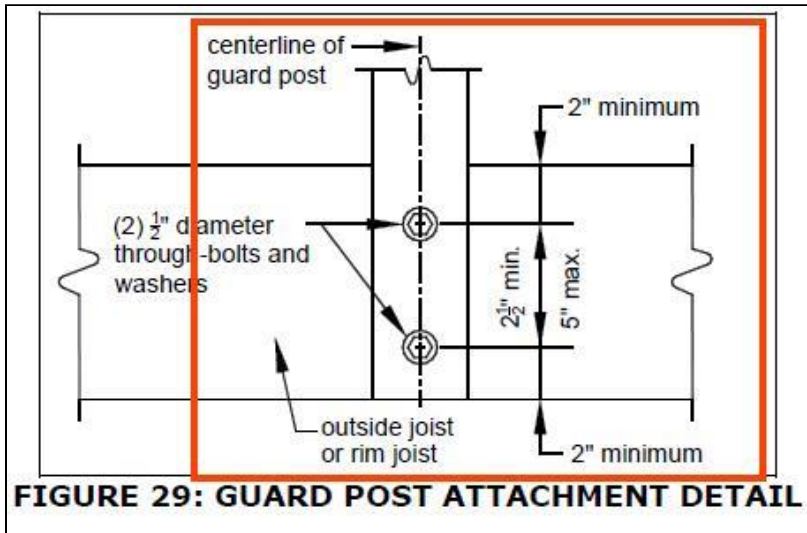
Loft guard rail attachment

B. (4) Improper post-to-beam/rim board attachment. NOTE: Posts (i.e. 4x4") should be attached full-width with 2 x 1/2" bolts (and washers). Repair as necessary and ensure proper structure at interior side.

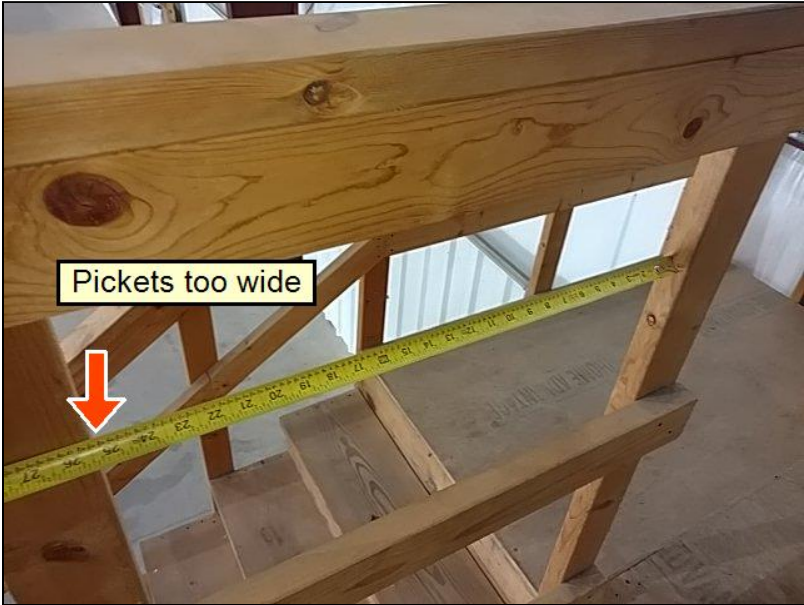
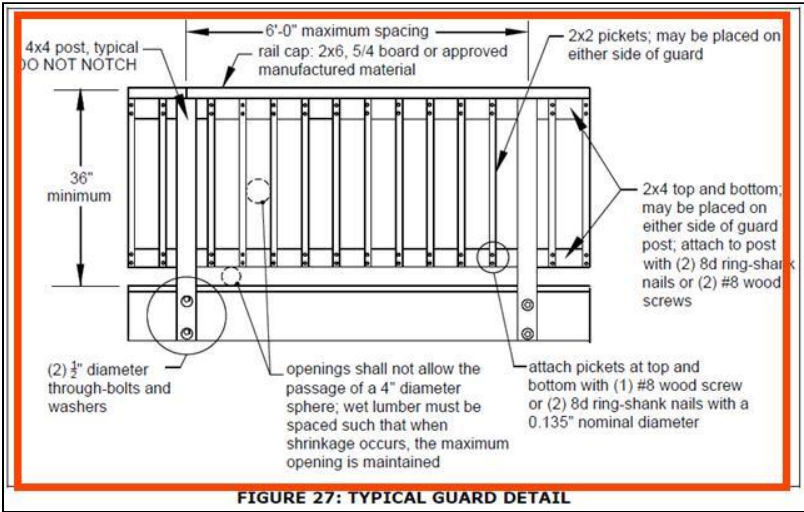
Loft guard rail

B. (5) Pickets too wide at loft guard rail. NOTE: Pickets at guard railings should not spaced wider than 4" apart. Repair as necessary.

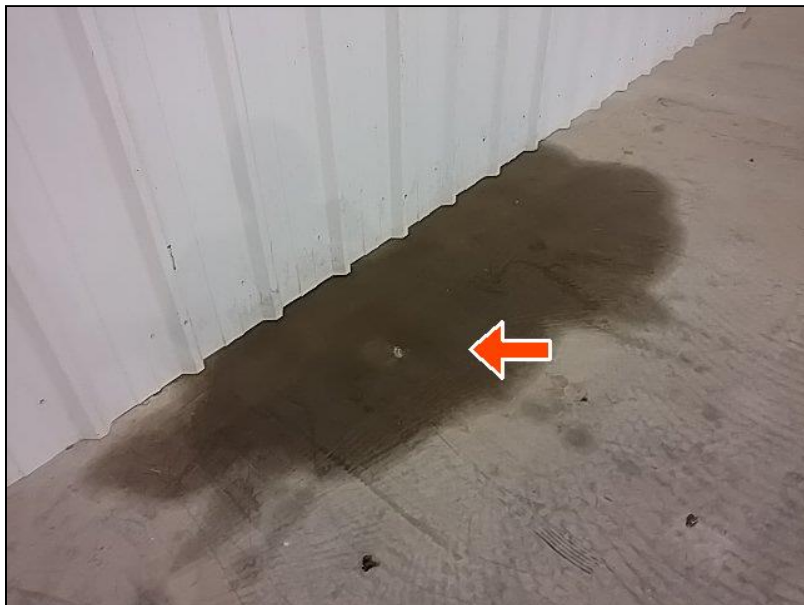
Warehouse, right

B. (9) Oily substance noted at warehouse at right side. Recommend Phase I inspection. Clean with approved materials and dispose at approved locations.

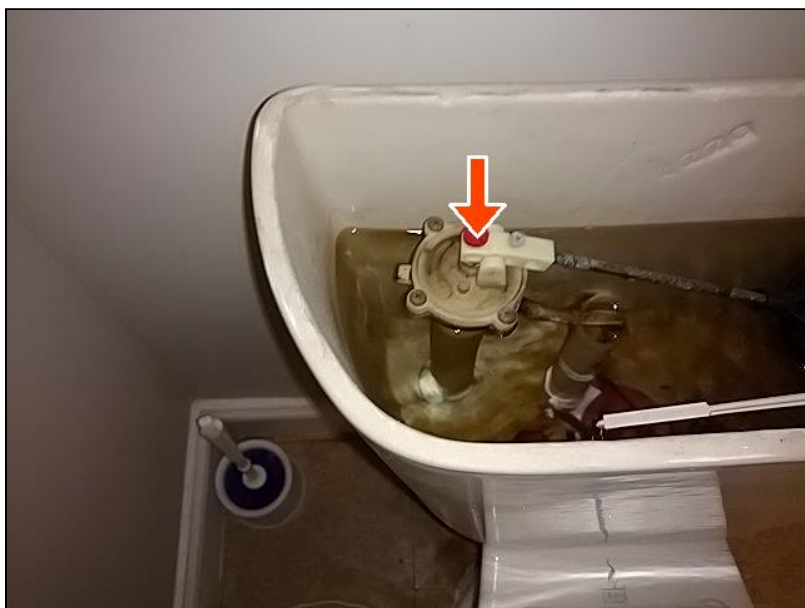
Women's bathroom

D. (1) The toilet flush tank at the women's bathroom runs continuously (the fill valve appears to be damaged). NOTE: Inspector closed supply valve after inspection.

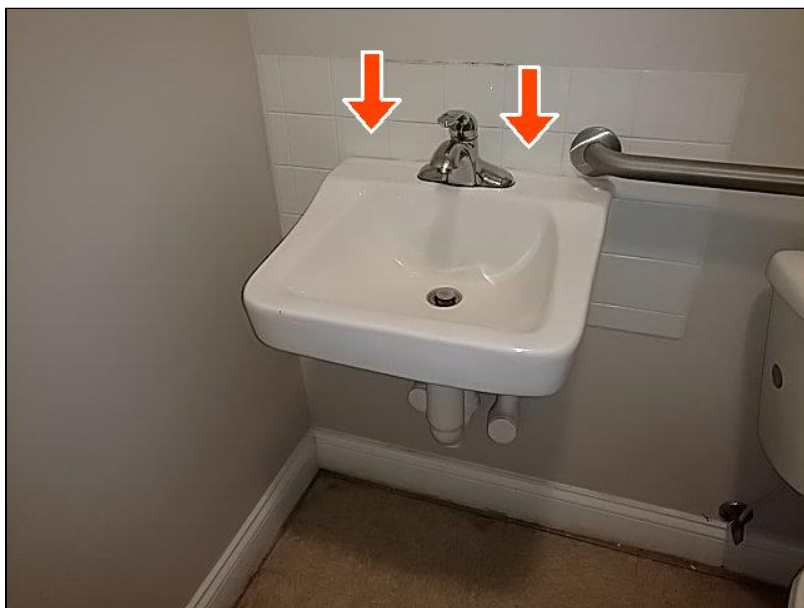
This location: Men's bathroom

D. (2) Loose sink(s) noted at women's/men's bathroom(s). Secure sinks as necessary.

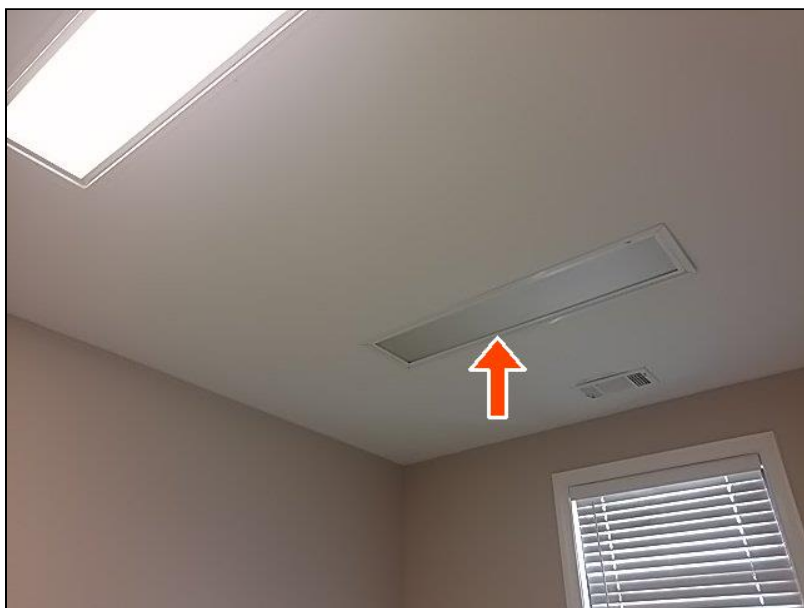
Rear left office

E. Not operating light fixture noted at rear left office. Replace light bulbs/evaluate circuits. Replace/repair as necessary.
