CHAMPIA

REAL ESTATE INSPECTIONS

Date of Inspection: 2/11/2012

Property Analysis Report

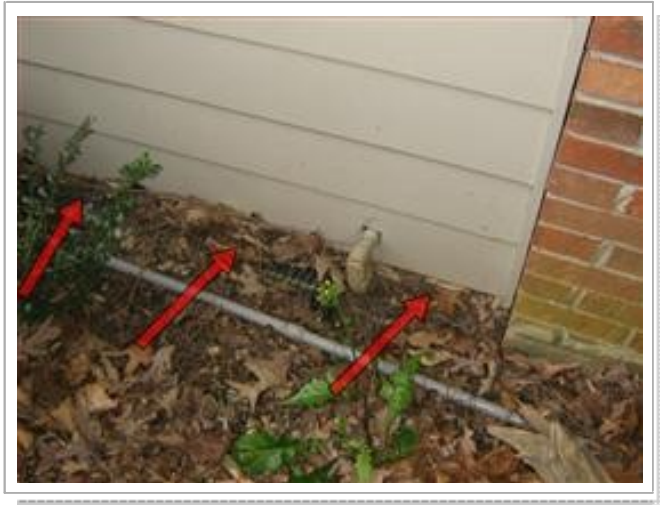
Figure Number 1

Siding at the front of the carport is in ground contact or too close to the soil, 6 inches of clearance to grade is recommended to prevent decay and infestation by wood destroying organisms. Recommend improving clearances.

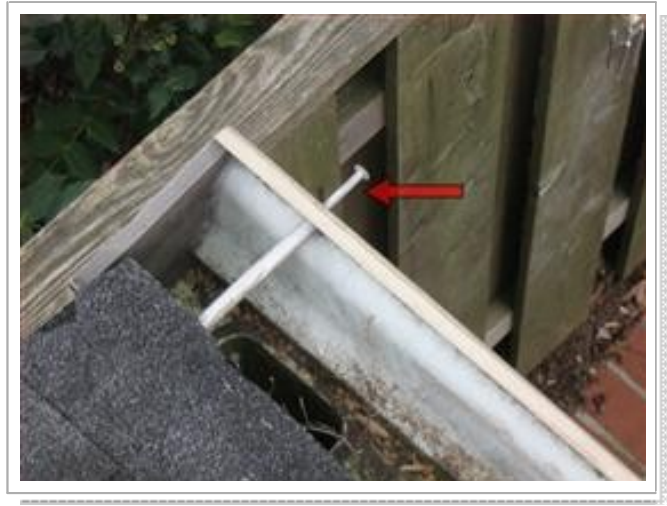
Figure Number 2

The gutter at the carport are loose and need to be secured.

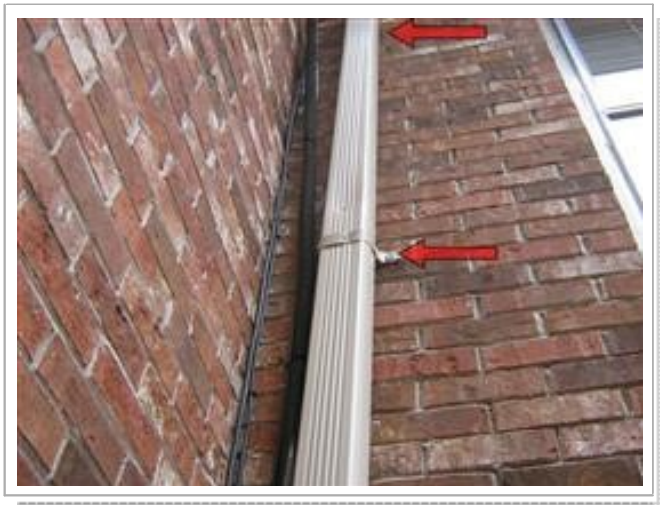
Figure Number 3

The downspout at the right rear is loose and needs to be secured.

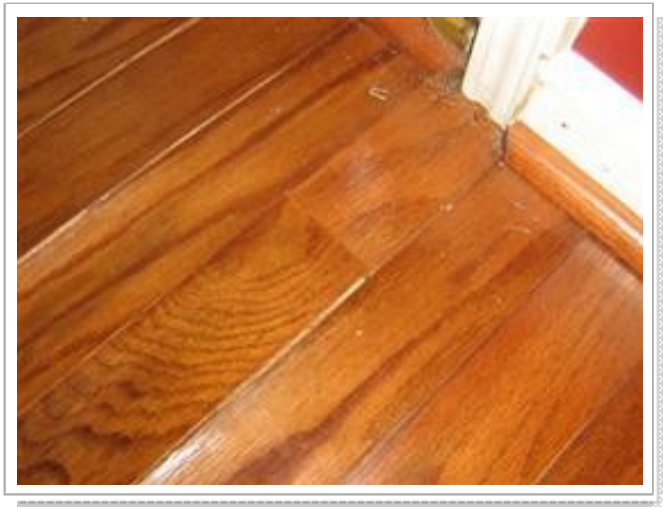
Figure Number 4

The wood flooring throughout the 1st floor has cupped indicating moisture. Moisture meter was used at front and rear rooms and the flooring is dry. Told that broken sewer main caused original leak that entered home. The floor will need replacement as it is a tripping hazard.

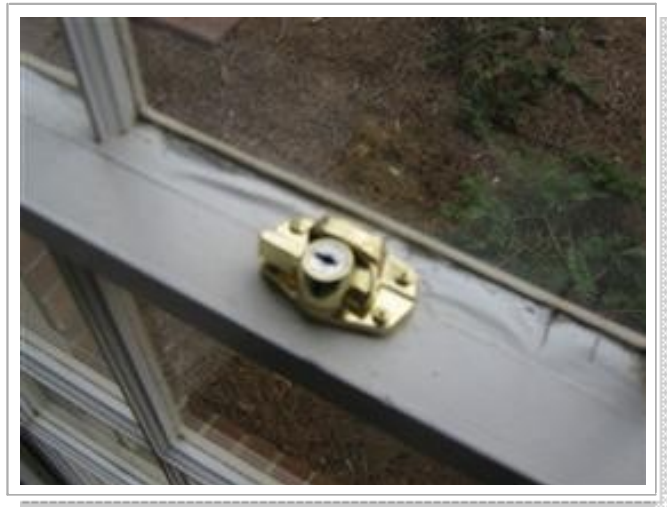
Figure Number 5

The keys are missing on the windows in the living room. Provide keys or replace lock.

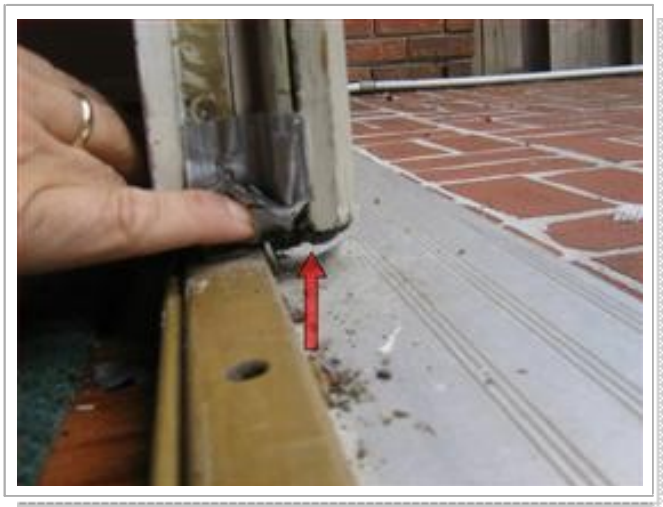
Figure Number 6

The left double door to the kitchen binds and will not open to the patio. Appears center astragal strip is binding door. Repair.

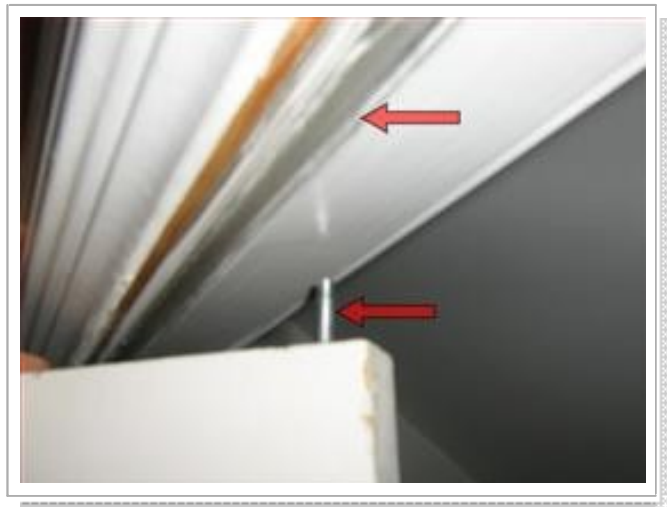
Figure Number 7

The hinge pins are missing or damaged on numerous double closet doors. Replace hardware as needed.

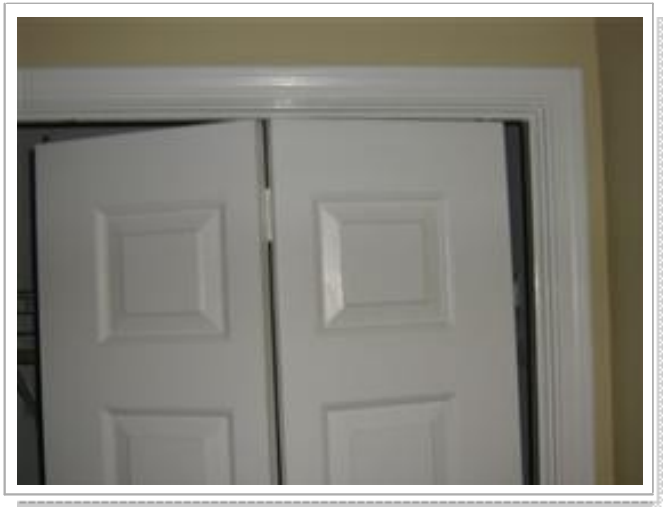
Figure Number 8

The hinge pins are missing or damaged on numerous double closet doors. Replace hardware as needed.

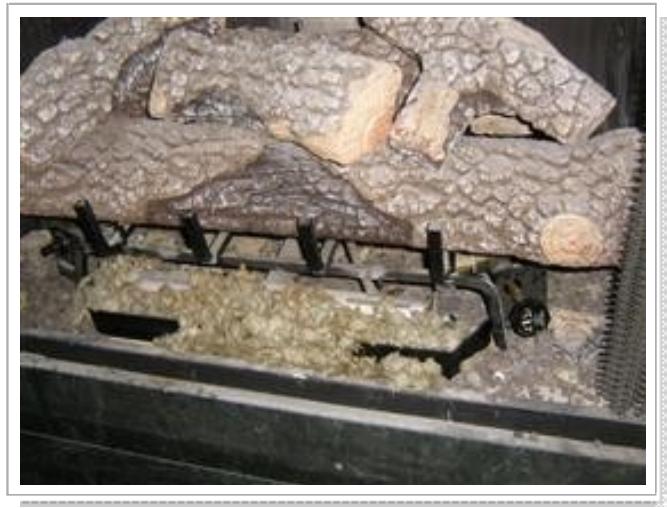
Figure Number 9

The gas starter at the fireplace did not work when tested. Repair as needed.

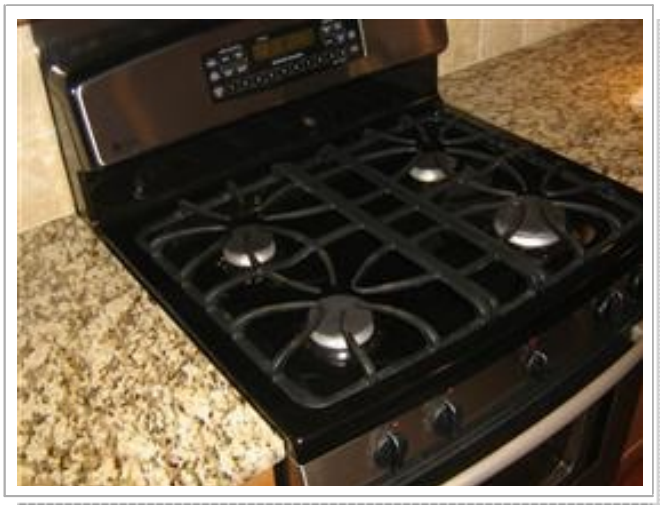
Figure Number 10

The anti tip device is missing for the range. Install as needed.

1. The anti-tip device is missing for the range. Install as needed. (See Figure #10)

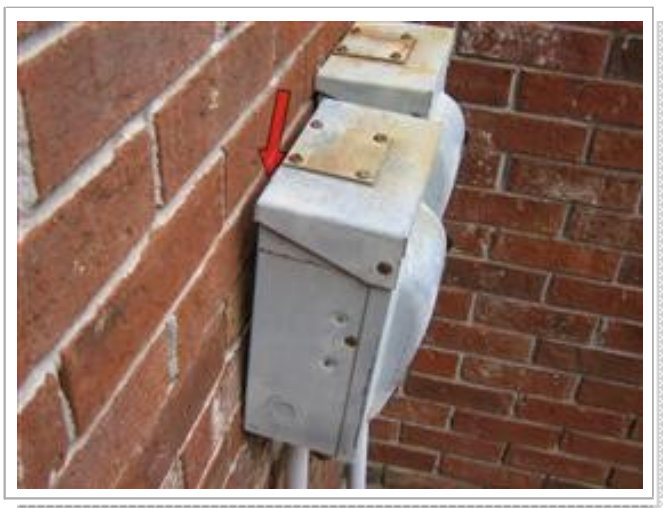
Figure Number 11

The electric disconnect can is loose at left rear exterior. Properly secure to wall.

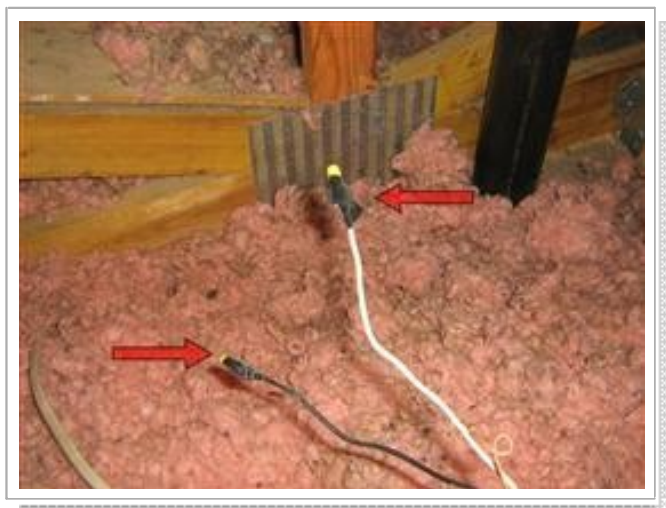
Figure Number 12

Flying wire splices were observed at the attic. All splices should be contained in closed junction boxes. Correct wiring as needed.

5. Flying wire splices were observed at the attic. All splices should be contained in closed junction boxes. Correct wiring as needed. (See Figure #12) (See Figure #13)

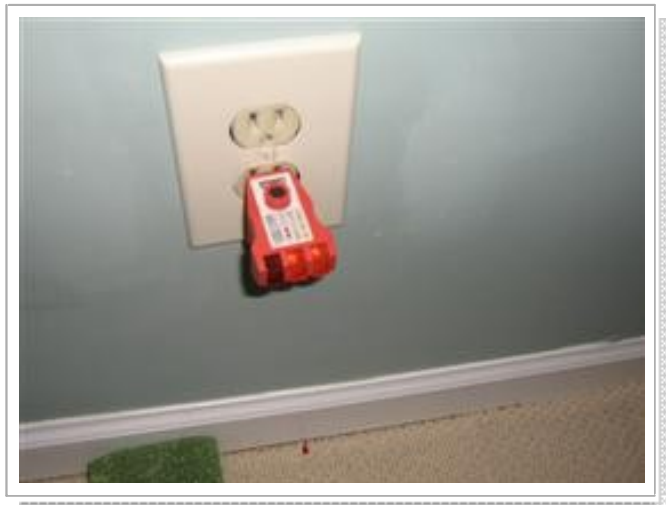
Figure Number 14

A receptacle is damaged in the master bedroom-right side . Replace receptacle.

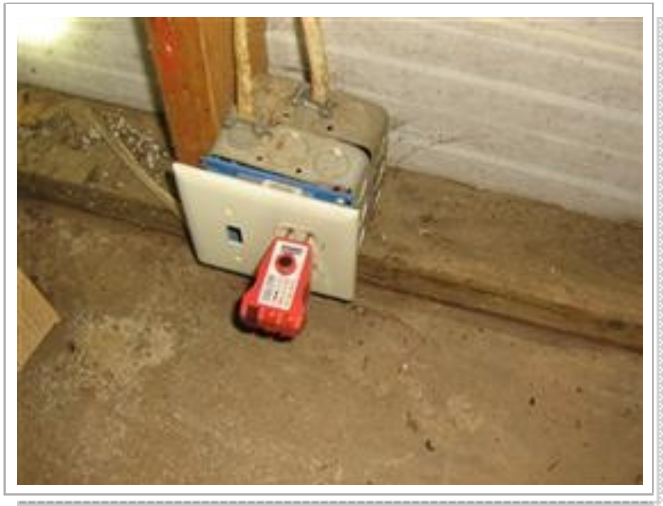
Figure Number 15

GFCI protection is missing for the receptacle in the carport and storage. Install GFCI protection.

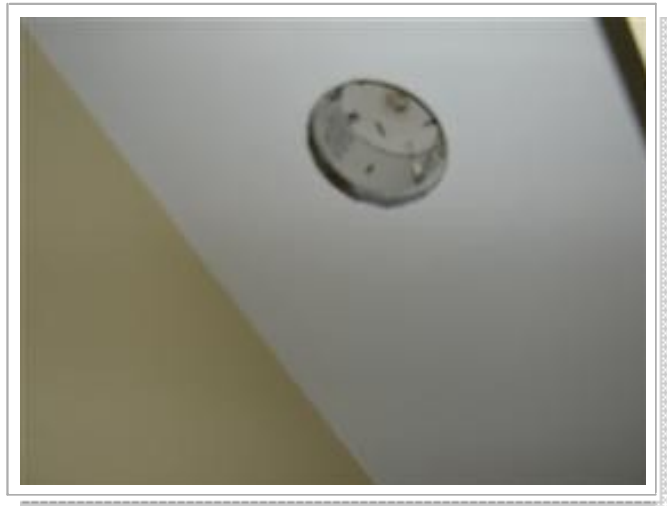
Figure Number 16

The light in the upper hall shower did not work when tested. Check for blown bulbs, repair fixture if needed.

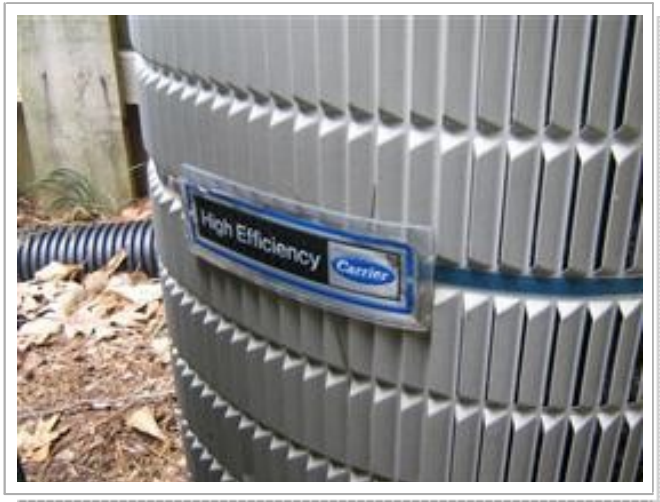
Figure Number 17

The cooling systems/ condensers are older(1994 & 1984) and has reached its average life expectancy. Replacement may be required at anytime.

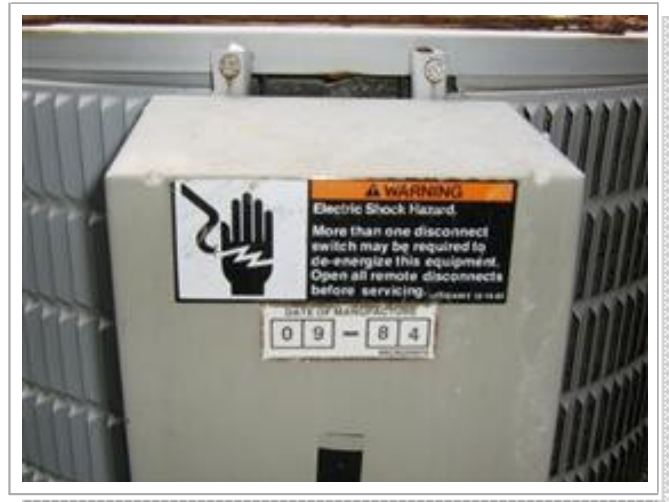
Figure Number 18

The cooling systems/ condensers are older(1994 & 1984) and has reached its average life expectancy. Replacement may be required at anytime.

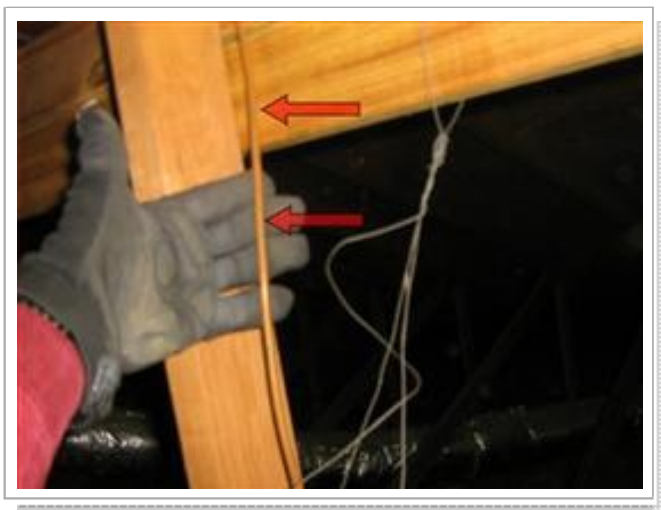
Figure Number 19

No insulation is installed on a waterline to humidifier in the attic. Water line could freeze and burst. Install insulation where missing.

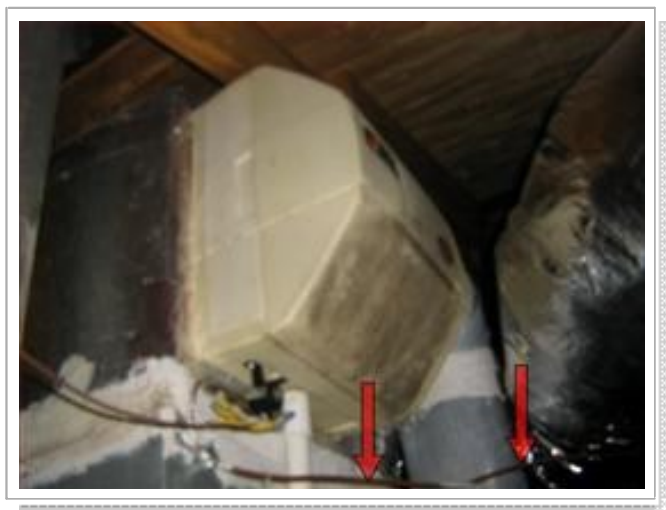
Figure Number 20

No insulation is installed on a waterline to humidifier in the attic. Water line could freeze and burst. Install insulation where missing.

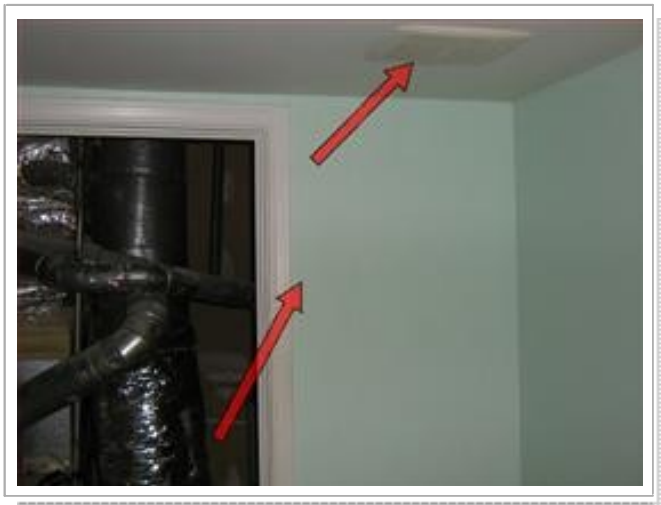
Figure Number 21

When turned on the powder room exhaust fan draws combustion products (carbon monoxide) from the furnace and water heater. Inadequate combustion air was observed to the furnace and water heater at closet. Recommend combustion air vents be added to furnace closet.

3. When turned on the powder room exhaust fan draws combustion products (carbon monoxide) from the furnace and water heater. Inadequate combustion air was observed to the furnace and water heater at closet. Recommend combustion air vents be added to furnace closet. (See Figure #21)

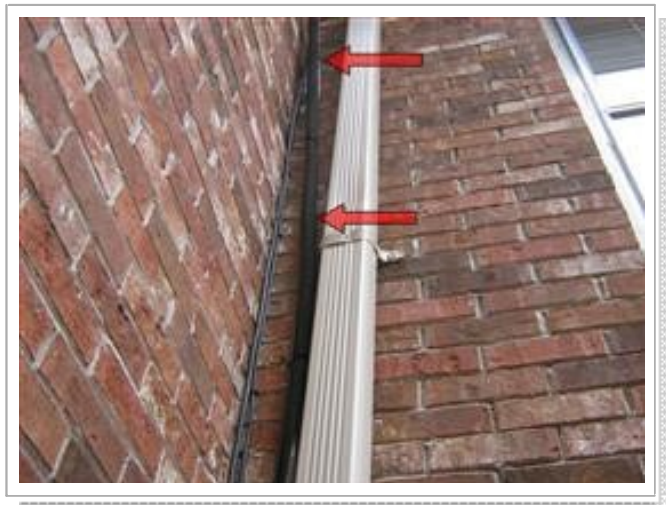
Figure Number 22

The Freon lines at right exterior do not have adequate support. Lines should be supported at 6-foot intervals. Add support as needed.

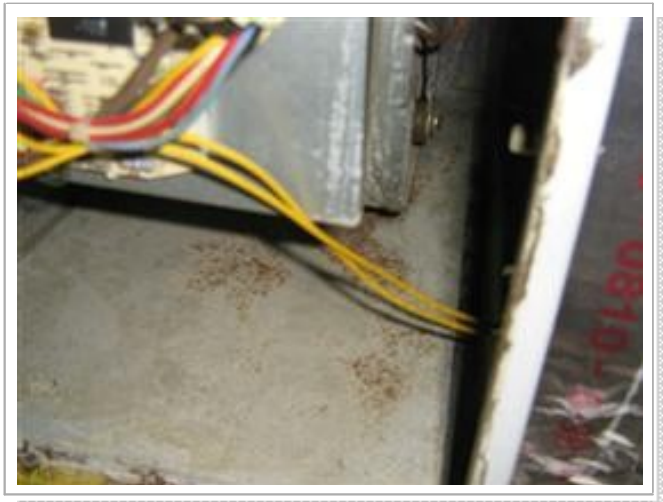
Figure Number 23

The blower motor and housing in the air handler for the main floor HVAC system is corroded. Recommend system be cleaned and evaluated by a qualified HVAC technician.

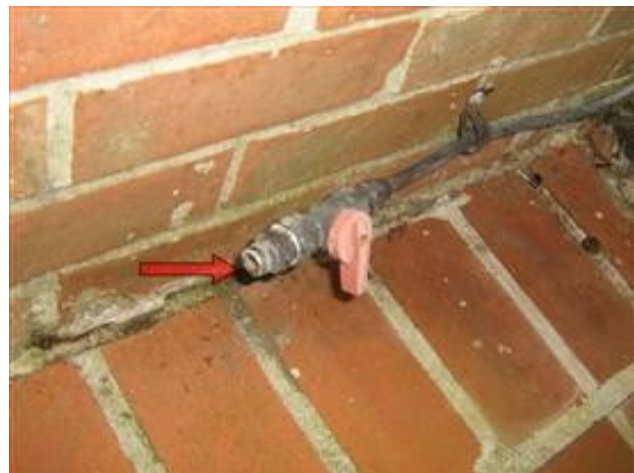
Figure Number 24

An uncapped gas line was observed at the rear patio. Cap the line.

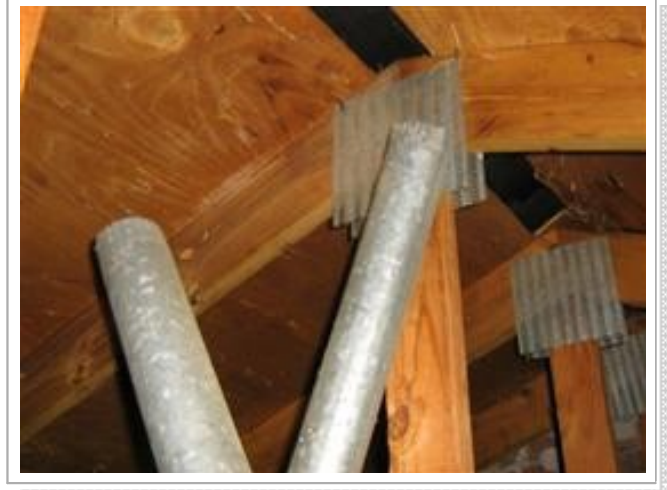
Figure Number 25

The bathroom exhaust fans are vented into the attic. Fans should be vented to the exterior.

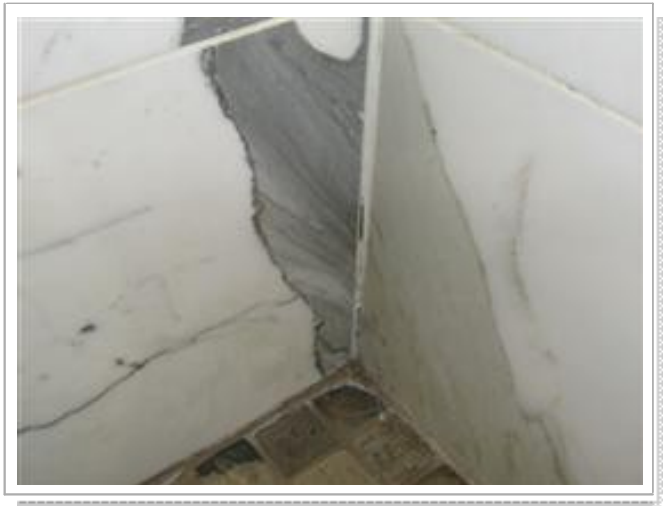
Figure Number 26

Grout is missing or deteriorated in the master bathroom shower. RegROUT/repair as needed.

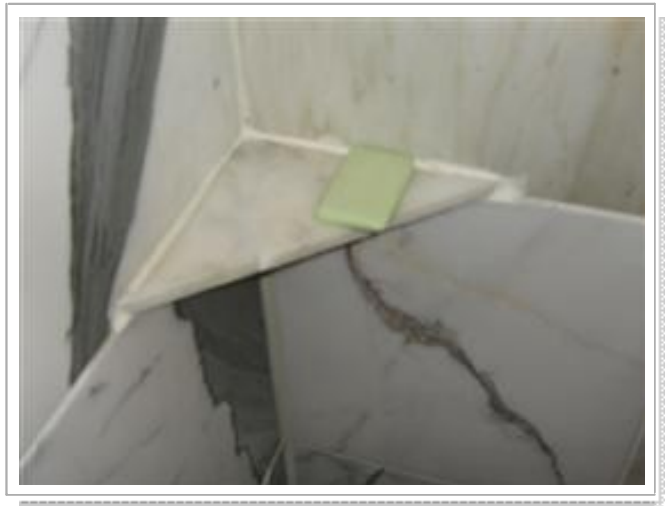
Figure Number 27

Tile shelves are cracked in master shower. Repair/ replace.

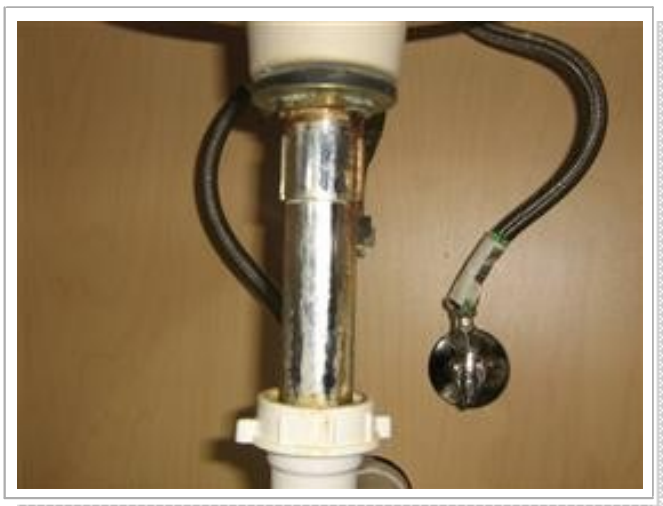
Figure Number 28

A leak was observed at a joint in the tailpiece under the master sink. Repair.

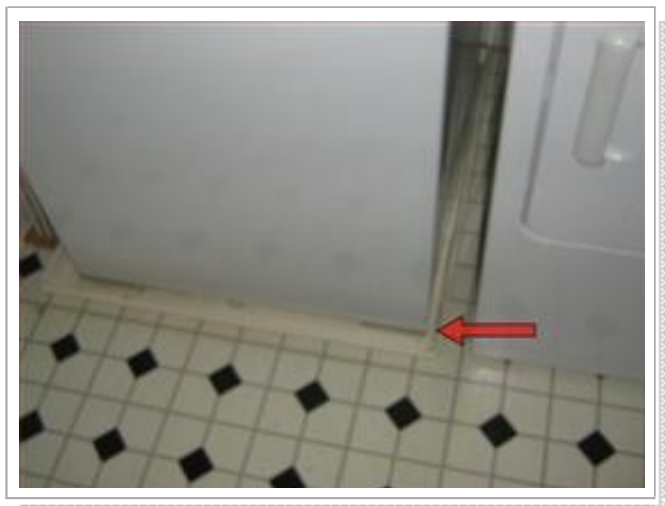
Figure Number 29

Drip pan under wash machine to prevent water damage if leaks occur is not connected to an exterior discharge pipe. Install pipe to exterior or install a water alarm in pan.

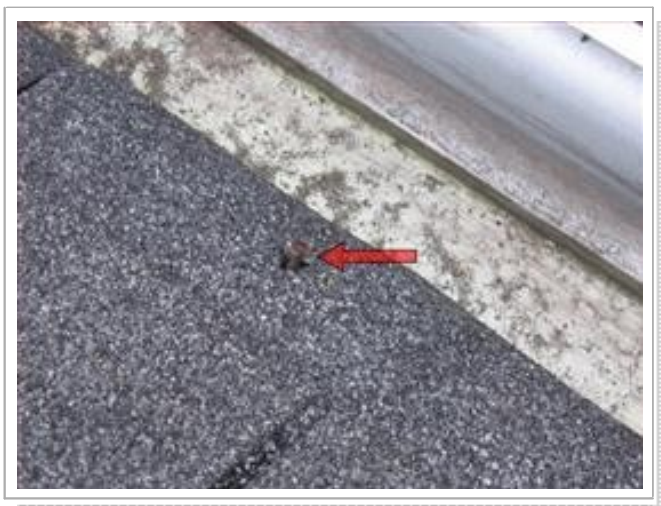
Figure Number 30

Nails have worked out of the roof sheathing and through the roof covering at rear of car port. Recommend loose nails be pulled and the holes in the covering sealed to prevent leaks from developing.

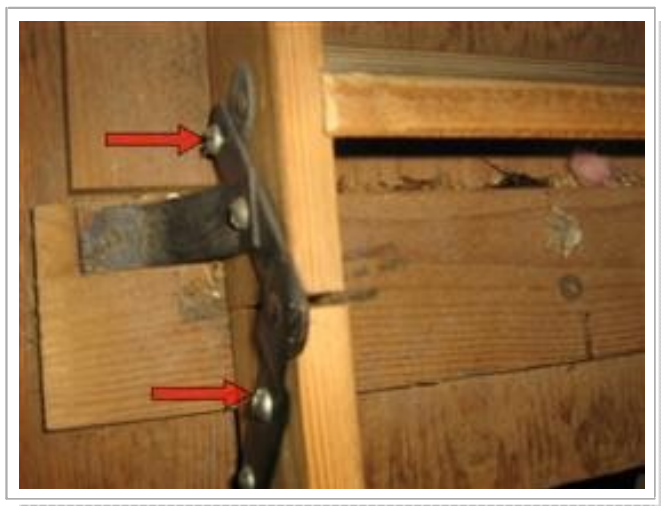
Figure Number 31

Loose or missing nuts and bolts were observed on the pull down stairs to the attic. Tighten and replace missing hardware as needed.

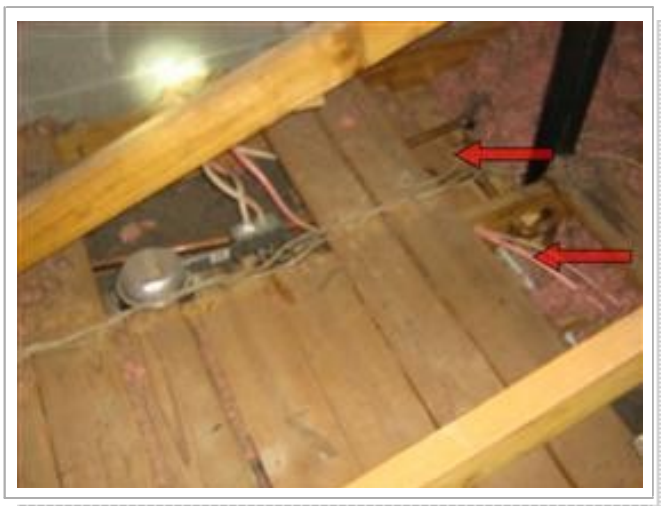
Figure Number 32

The depth of insulation above the ceilings is low by today's standards. Recommend installation of additional insulation to improve energy efficiency. A minimum of R-30 insulation is recommended.

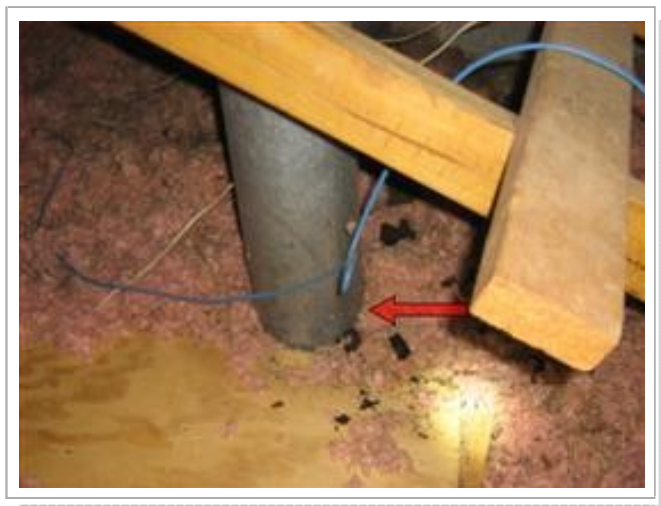
Figure Number 33

Insulation against flue pipe in attic. One inch clearance is required from combustibles on a type B flue pipe. Insulation is considered combustible. Modify Insulation away from flue, install collar.
