Property Condition Assessment

Champia Real Estate Inspections, LLC

Date: 3/29/2018	Time: 09:00:00 AM	Report ID: 31646
Property: [REDACTED]	Customer: [REDACTED]	Real Estate Professional: [REDACTED]

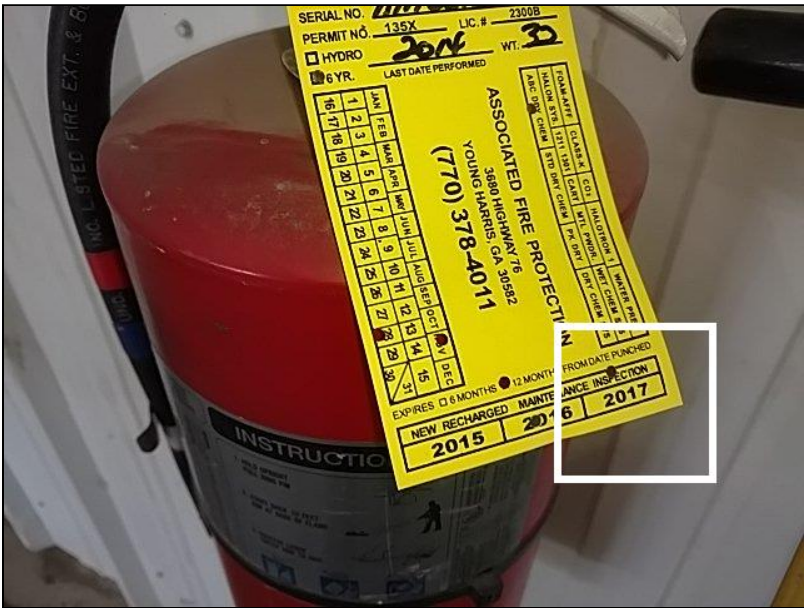
This location: Warehouse

C. Fire extinguishers noted at numerous locations. NOTE: All equipment appears to be in working order. Recommend to consult with the local fire marshal for local requirements.

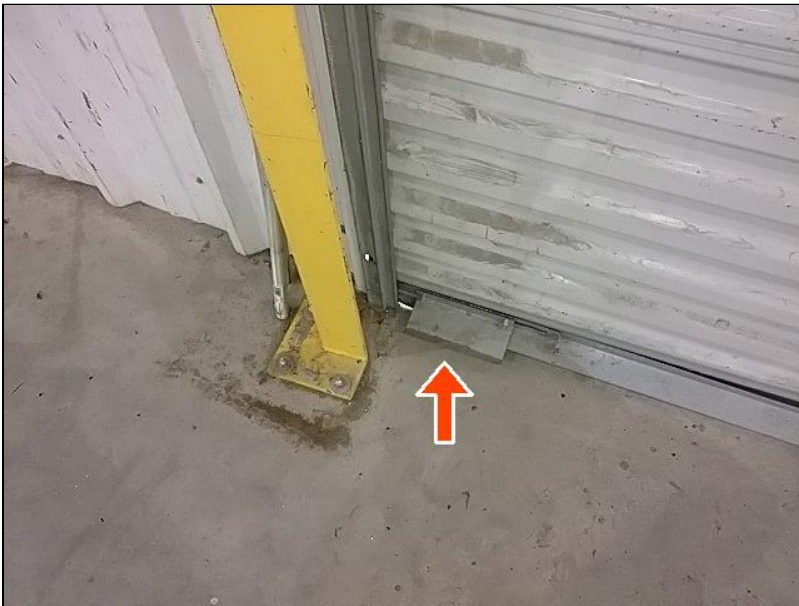
Right overhead door

A. (2) Left latches at right and left overhead door did not engage. Adjust as necessary.
