Property Condition Assessment

Champia Real Estate Inspections, LLC

Date: 3/29/2018	Time: 09:00:00 AM	Report ID: 31646
Property: [REDACTED]	Customer: [REDACTED]	Real Estate Professional: [REDACTED]

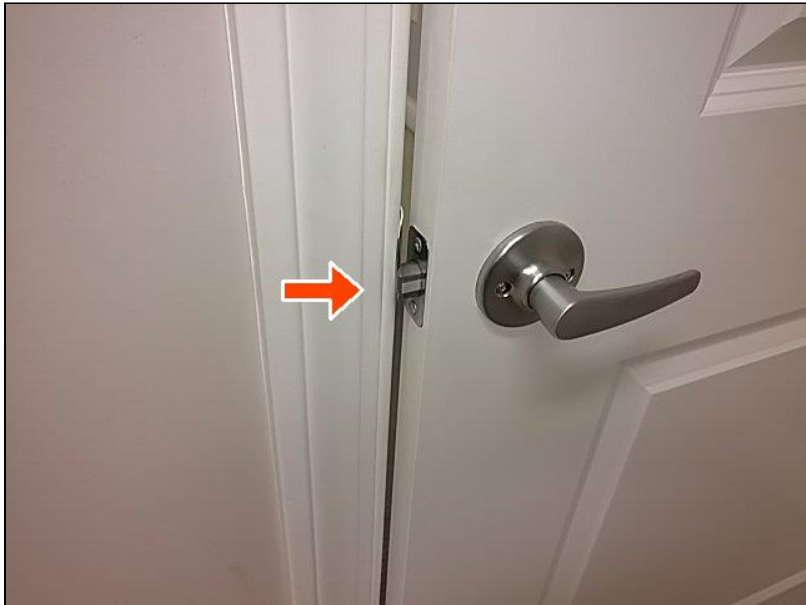
Rear right office

A. Door at rear right office binds. Adjust as necessary.
